**COUNTY OF HUMBOLDT EXTRACTION REVIEW TEAM (CHERT)
2001 POST-EXTRACTION REPORT**

County of Humboldt extraction Review team (CHERT)

Humboldt County Board of Supervisors

April 2, 2003

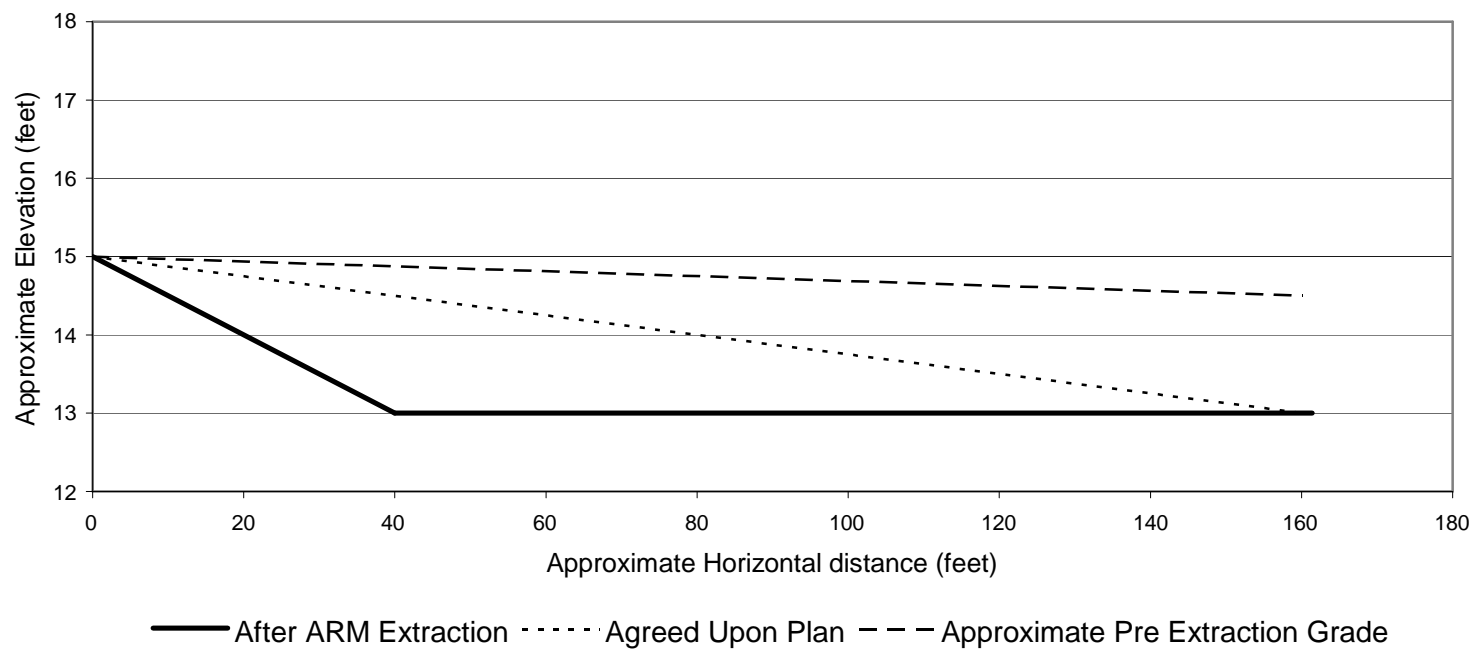
Schematic of Various 2002 Grades at Johnson-Spini Left Bank Bar

<p>Was the extraction volume at this site within the approved plan limits? <i>Yes.</i></p>		
<p>Was the entire post extraction footprint essentially within the approved plan limits? <i>Yes.</i></p>		
<p>Was the entire post extraction bar surface elevation essentially within the approved plan limits? <i>No. A condition of the plan approval was that the excavation floor would begin to rise at cross section 13 and would daylight at cross section 4. (The distance between cross section 13 and cross section 4 is 160 feet.) Arcata Readimix clearly agreed to do this and it was made a condition of the plan approval. Apparently, neither the surveyor nor the equipment operators were informed of this condition. Instead, the operators maintained the elevation of the excavation floor while moving upstream from cross section 13 for a distance of about 120 feet to 140 feet (distance varied) and then abruptly rose 2 to 3 feet to daylight (within 20 to 40 feet) at cross section 4. A schematic sketch follows.</i></p>

Were impacts within expected limits? No. This is the second year in a row that this operator has violated their permit conditions at this bar. In October 2000, after their Corps permit had expired, Arcata Readimix removed gravel from the head of this bar; more specifically they significantly lowered the bar surface at the head of the overflow channel. Consequently, a significant portion of this bar was eroded away and washed downstream during the relatively low flows experienced during the winter of 2000-2001. The gullies formed in the bar surface are easily seen in the May 7, 2001 aerial photograph. This significantly altered the form and reduced the function of the bar. This also resulted in excess sediment being washed from the gullies into the main channel near cross section 13 and between cross sections 5 and 6.

During the summer of 2001, Arcata Readimix again violated their permit agreement and over extracted at the head of the bar. This violation significantly depleted the mass of gravel at the head of the bar. CHERT and others had predicted that this extraction violation, in combination with the 2000 excavation would likely divert much of the stream and cause it to flow over the head of the bar. The effects would be: 1) to capture and divert the main flow, 2) create a braided flow, 3) wash away much of the bar surface and 4) reduce the quality of salmonid habitat. During an inspection in March 2002 CHERT observed that these effects did in fact occur. The head of the bar was gone and the sediment from the head of the bar had been swept downstream. In recent years, at this time the stream flow at this location would be confined to a single well-defined channel crossing over a riffle upstream of the bar. However, at the time of the March 2002 visit the streamflow was braided, i.e., divided into five smaller much shallower channels across the remaining bar surface resulting in a significant reduction in salmonid habitat quality. Salmonid smolts migrating downstream at this time were subjected to an increased risk of predation and stranding.

If impacts were not within expected limits, how could have these impacts been avoided or reduced? Had the operator submitted cross section 4a with their plan CHERT would likely have noticed that the surveyor was not aware of the agreement that had been reached during consultations with CHERT, the California Department of Fish and Game and Arcata Readimix. Action could then have been taken to communicate the approved plan throughout the Arcata Readimix organization. Had CHERT required additional planning survey information, for example a sketch of the pre extraction and proposed bar surface profile, CHERT would likely have noticed that the surveyor was not aware of the agreement. Action could then have been taken to communicate the approved plan throughout the Arcata Readimix organization. CHERT provided a written description of the plan concept. If the operator had read the agreement and communicated its content to their surveyor their surveyor would have understood the plan concept or at least might have questioned the apparent differences between what the operator wanted to do and the CHERT recommendation. When in doubt, the Corps or CDFG could require the operator to carefully explain the excavation plan to their consultants and surveyors in the presence of knowledgeable regulatory witnesses. Furthermore, the plan and boundary markings could be explained to equipment operators in the presence of knowledgeable regulatory witnesses prior to beginning extraction.
