Surface Water Discharge Measurements Tech Memo 09-23-2020 to 12-21-2020

Memo # and Date: GHD012422, 1/11/2021: Updated 1/7/2022; Updated 1/24/2022; Updated 1/26/2022

Project: Eel River Groundwater Assessment

Client: Humboldt County, GHD

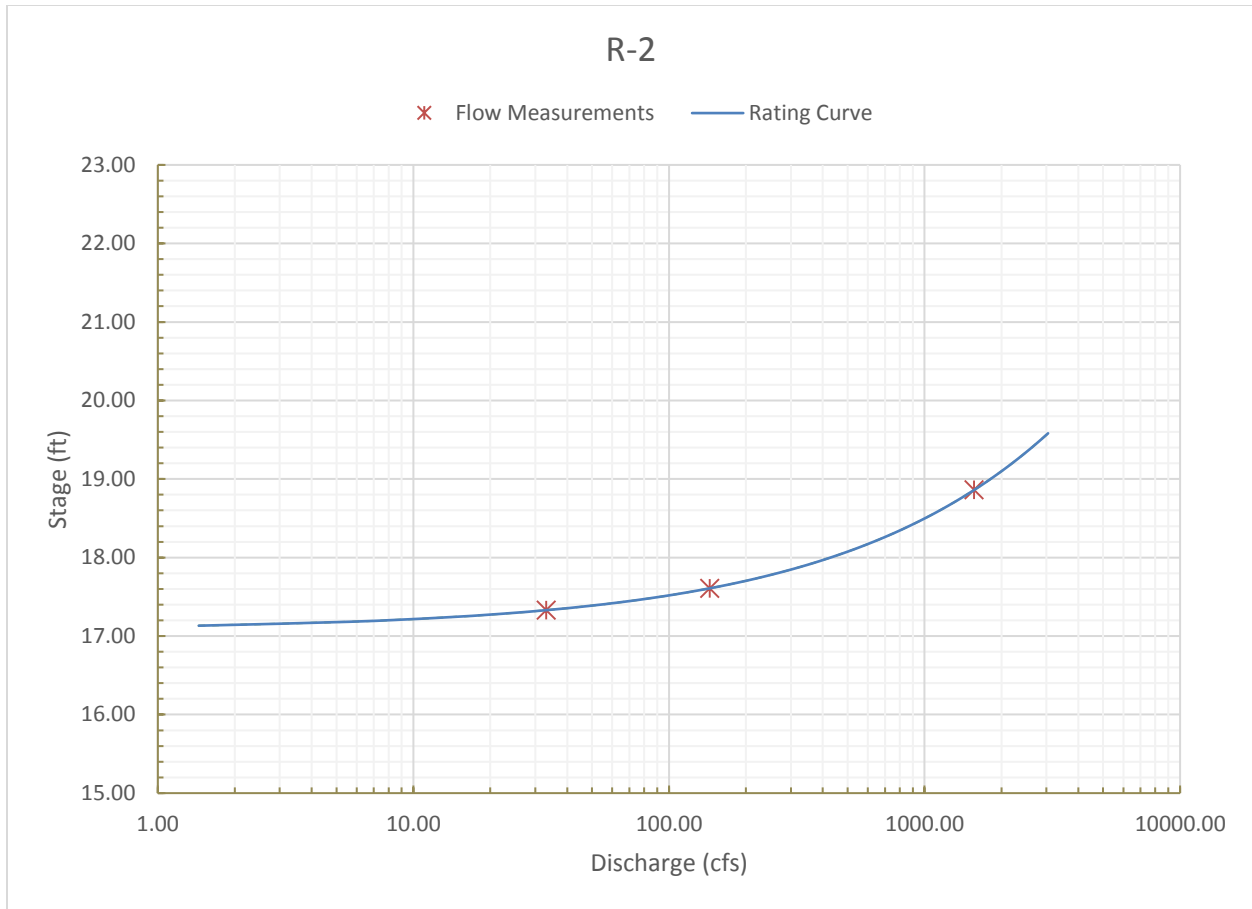
The rating equation for R-2 is Equation 1 and Figure 2, where Q is the discharge. The Stage is the water surface elevation (ft) corrected to true elevation and 17.082 is the true elevation of the stage of zero flow (SZF) in feet.

Equation 1. R-2 Rating Equation $Q = 507.124 * (Stage - 17.082)^{1.956}$

The standard error is 0.097% and R Squared is 1.0000.

Figure 2. Rating curve for R-2.

The rating curve for R2 will be different above the highest measured flow since a side channel at the hydraulic control became active and will influence the SZF at higher discharge. Normal wintertime movement of the gravel in the channel will require recalibration of the stage/discharge relationship.

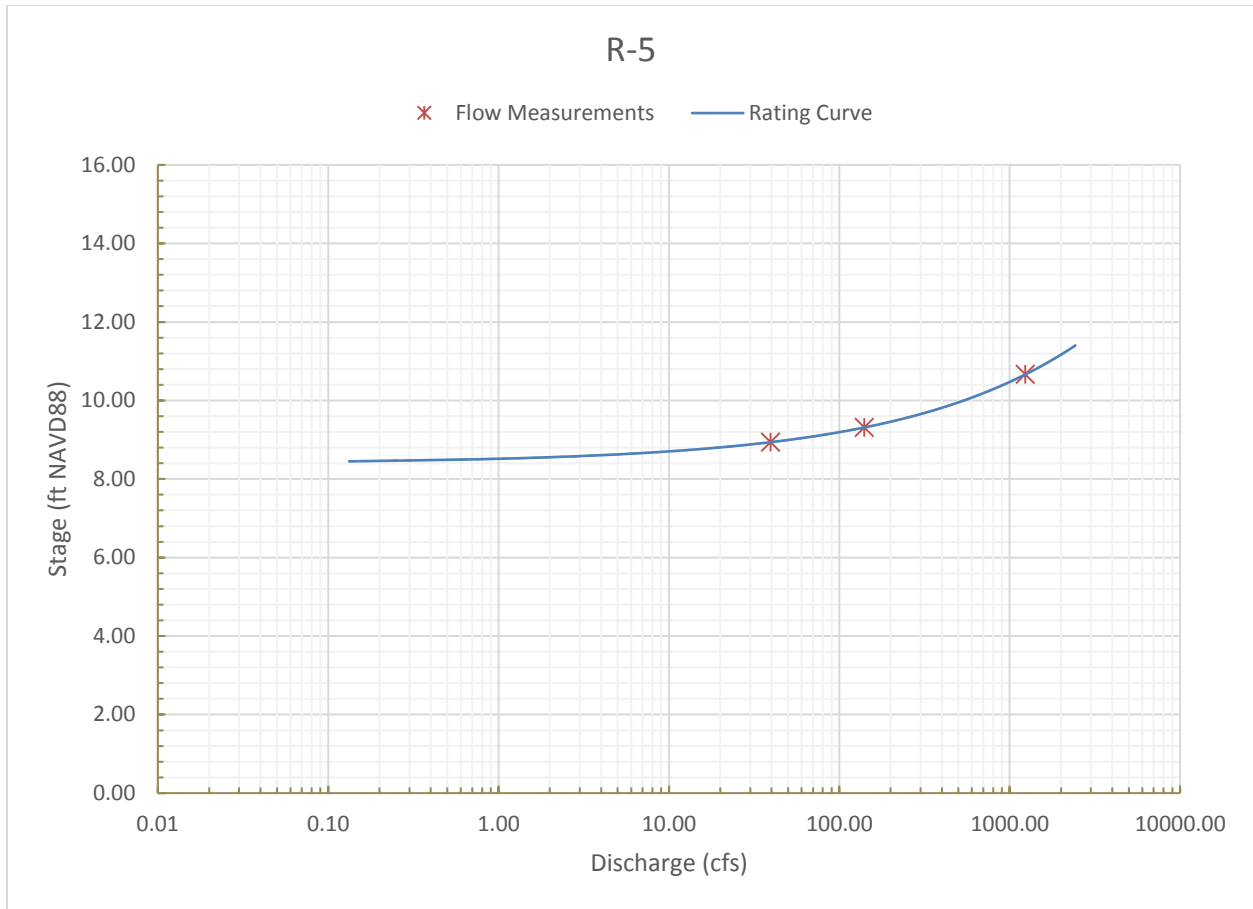
The rating equation for R-5 is Equation 2 and Figure 3, where Q is the discharge. The Stage is the water surface elevation (ft) corrected to true elevation and 8.482 is true elevation of the SZF in feet.

Equation 2. R-5 rating equation. $Q = 221.301 * (Stage - 8.482)^{2.277}$

The standard error is 0.002% and the R Squared is 1.0000.

Figure 3. Rating curve for R-5.

The rating curve for R-5 will be better than R-2 at higher flows since there is no opportunity for a side channel to form in the control. The useful high range of this rating curve will be approximately 2.5 times the high calibration flow (approximately 3000 cfs). Normal wintertime movement of the gravel in the channel will require recalibration of the stage/discharge relationship.

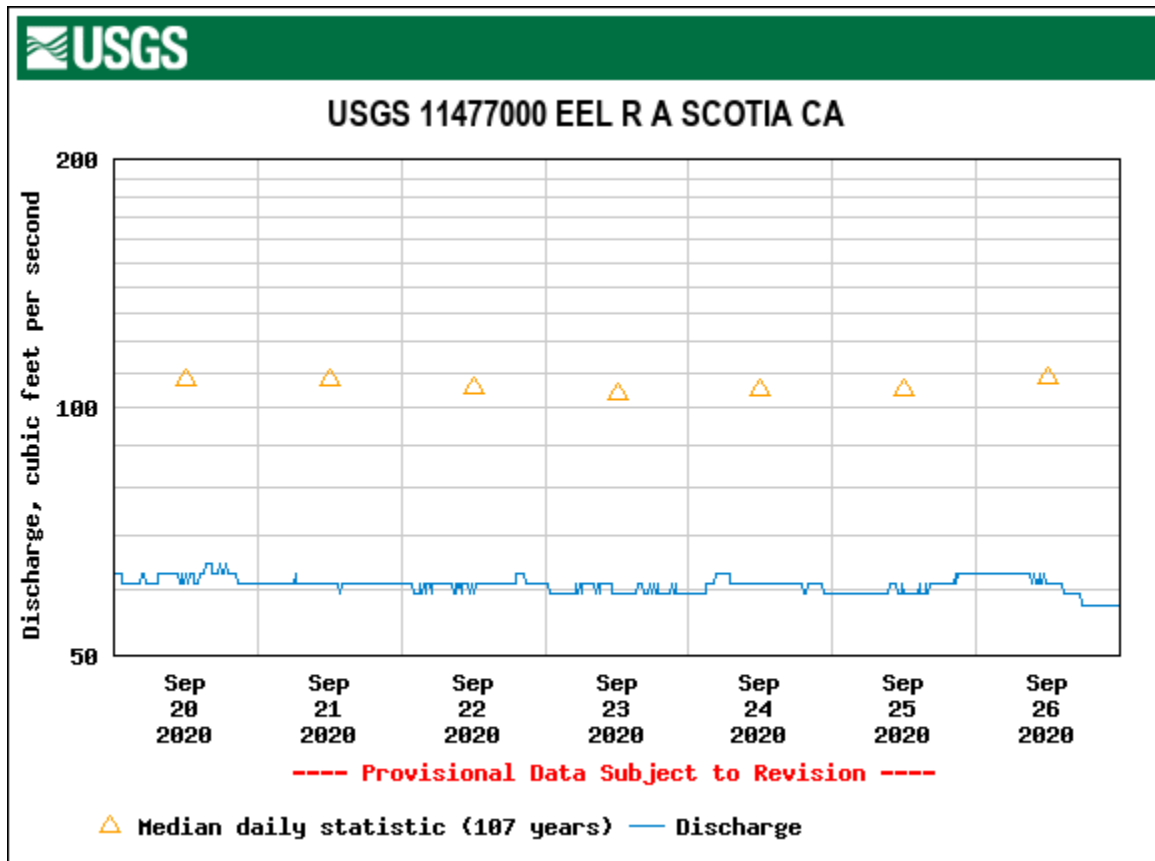
The nearest USGS stream gage (11477000) is located in Scotia, approximately 7.7 river miles upstream of R-3. On 23 September, the gage reported a discharge of 60.9 cfs (Figure 2). A rain event occurred on 24 September and a CoCoRaHS station located in Fortuna (CA-HM-94) recorded 0.19 in of rainfall. The Scotia gauge did not report a significant increase in streamflow resulting from this event. On 25 September, the Scotia gage reported a streamflow of 60.9 cfs at the time we made a measurement at QM-3.

Figure 2. USGS hydrograph for Eel River at Scotia; 20 Sep 2020 – 26 Sep 2020

The most recent field measurement made by USGS at the Scotia gage was on 16 September 2020. Technicians measured a discharge of 57.1 cfs at a stage height of 8.01 ft and rated the quality of the measurement “fair.” Using the current stage-discharge rating, a stage height of 8.01 ft is equivalent to a discharge of 60.9 cfs.

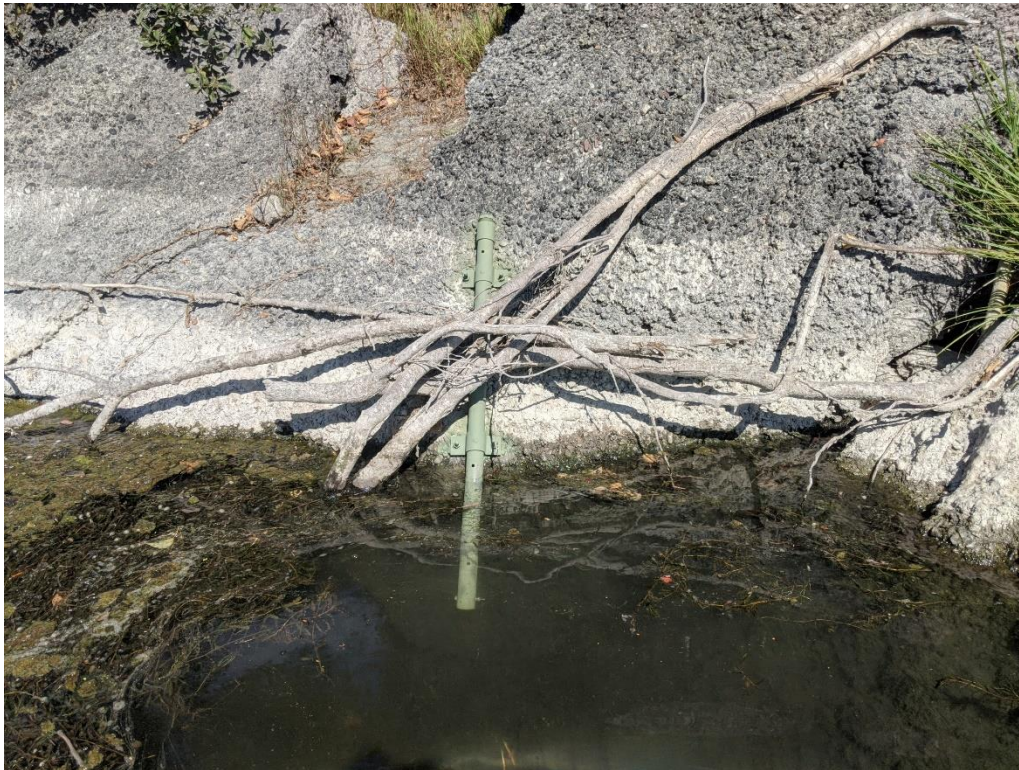
R-5 is located on the north bank of the river and is accessed through the former gravel plant at the Palmer Boulevard exit on Highway 101 (Figure 3). The device is housed in a PVC housing anchored to a concrete slab with concrete anchor bolts and is camouflaged with paint and vegetation to deter opportunistic vandalism. Three benchmarks were established in this location: a blaze orange spot on a rip-rap slab, the upstream top concrete anchor bolt, and a nail in the base of an alder tree upslope from the gauge.

Figure 3. Gauge in housing at R-5. Additional vegetation was added later for increased camouflage.

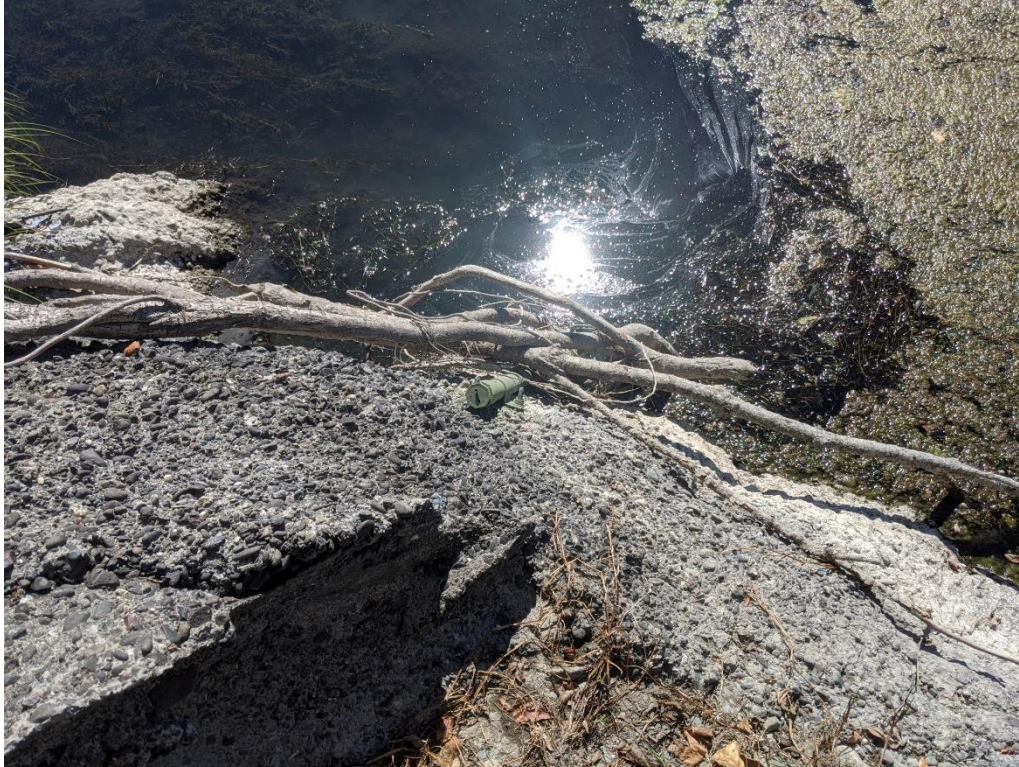
Figure 4. BM1 at R-5: upstream (left) anchor bolt

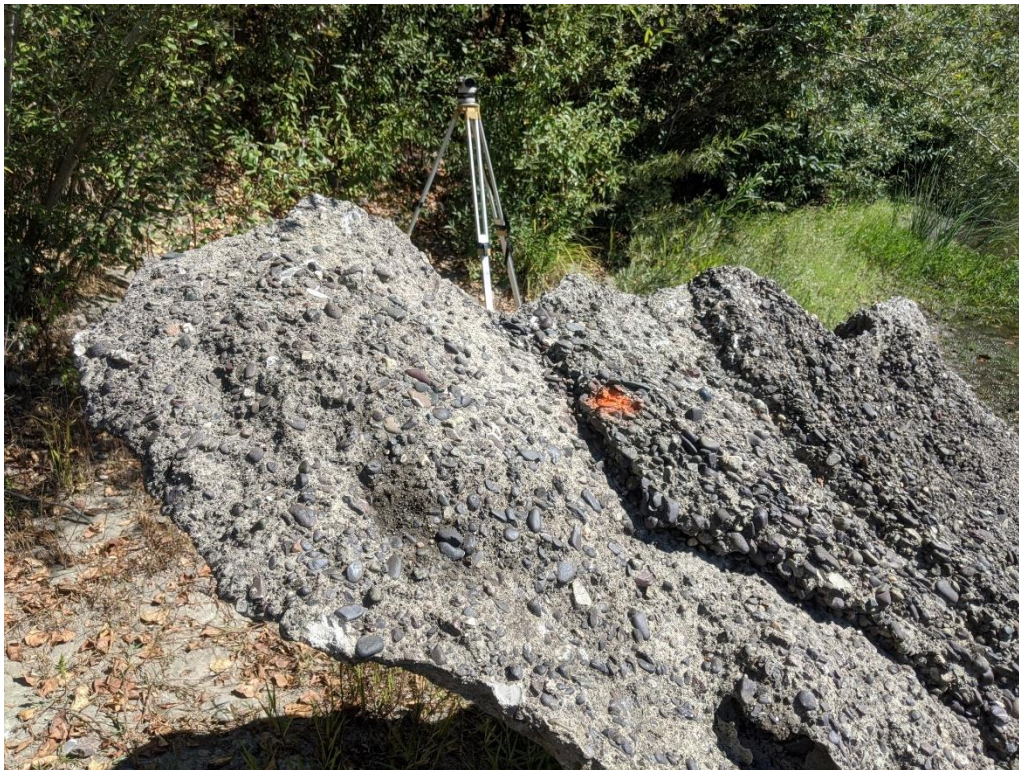
Figure 5. BM2 at R-5: blaze spot on concrete rip-rap

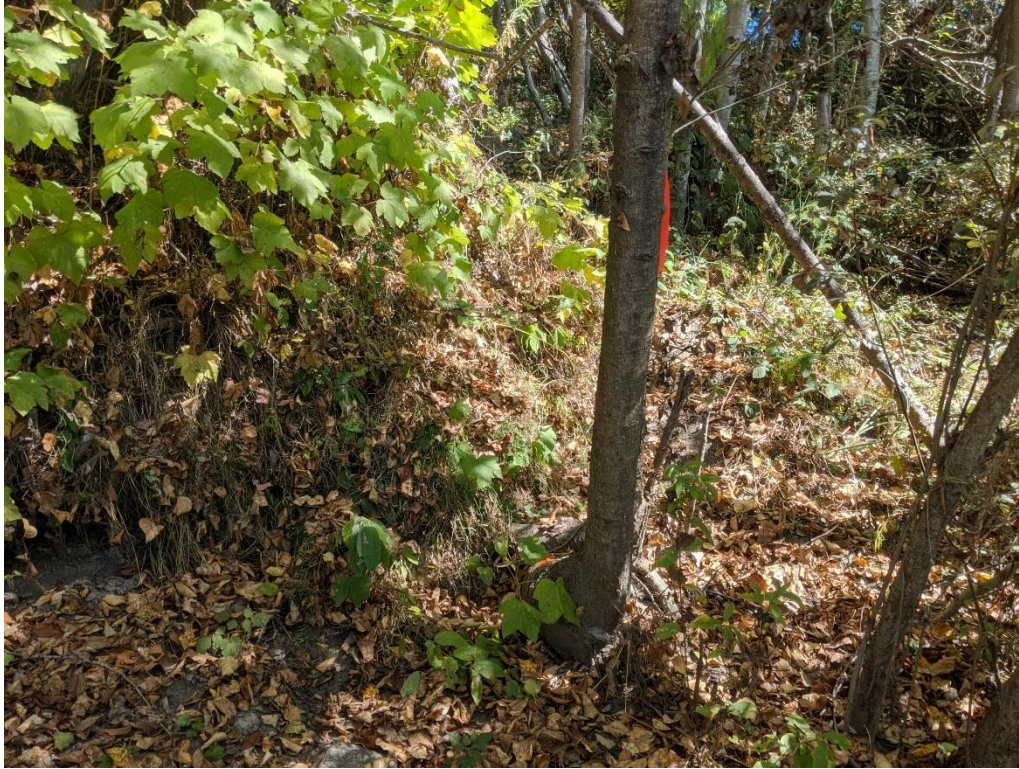
Figure 6. BM3 at R-5: nail in base of alder

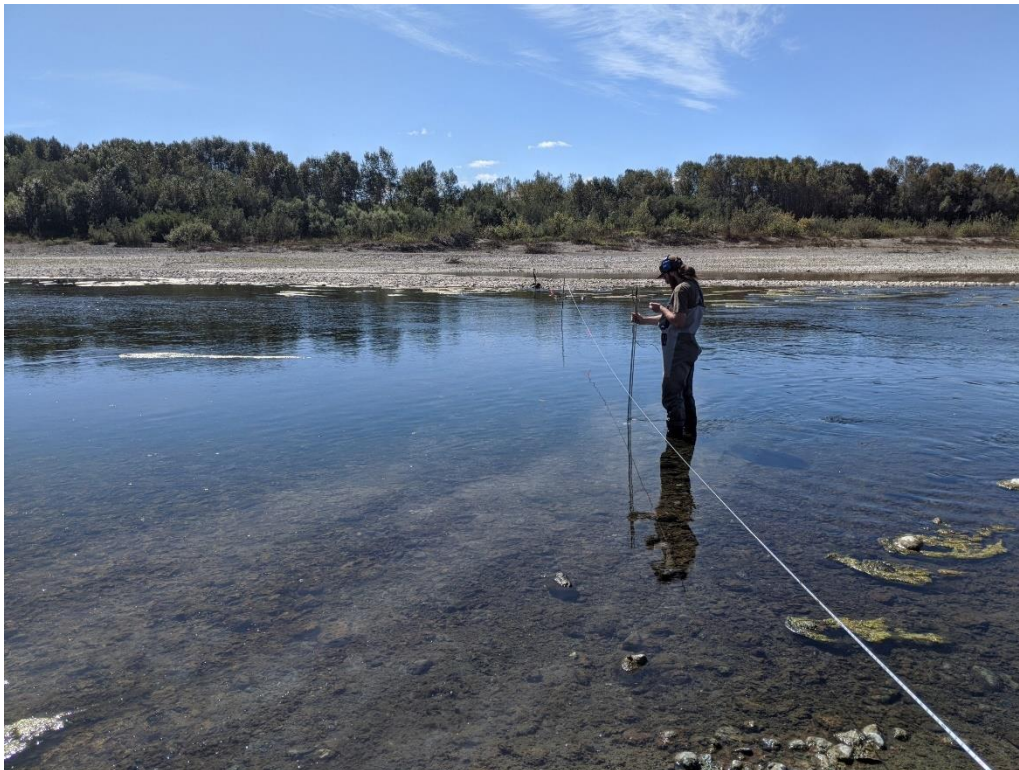
Figure 7. Streamflow measurement at QM-5

Two discharge measurements were made on 23 September 2020: one below the R-5 gauge at QM-5 (Table 5; Figure 7) and one below the R-2 gauge at QM-2 (Table 6; Figure 12). The measurement at QM-3 (below R-3) was made on 25 September 2020 (Table 7; Figure 13). QM-3 was accessed via East Ferry Road in Fortuna. Velocities at QM-5 and QM-3 were made using a Gurley Mini-type current meter, and velocities at QM-2 were made using a Price AA-type current meter. All velocity calculations were made using the USGS standard rating equations.

On 23 September, the streamflow at QM-5 was 39.42 cfs—6.33 cfs more than at QM-2, which had a streamflow of 33.09 cfs. On 25 September, streamflow at QM-3 was 38.50 cfs.

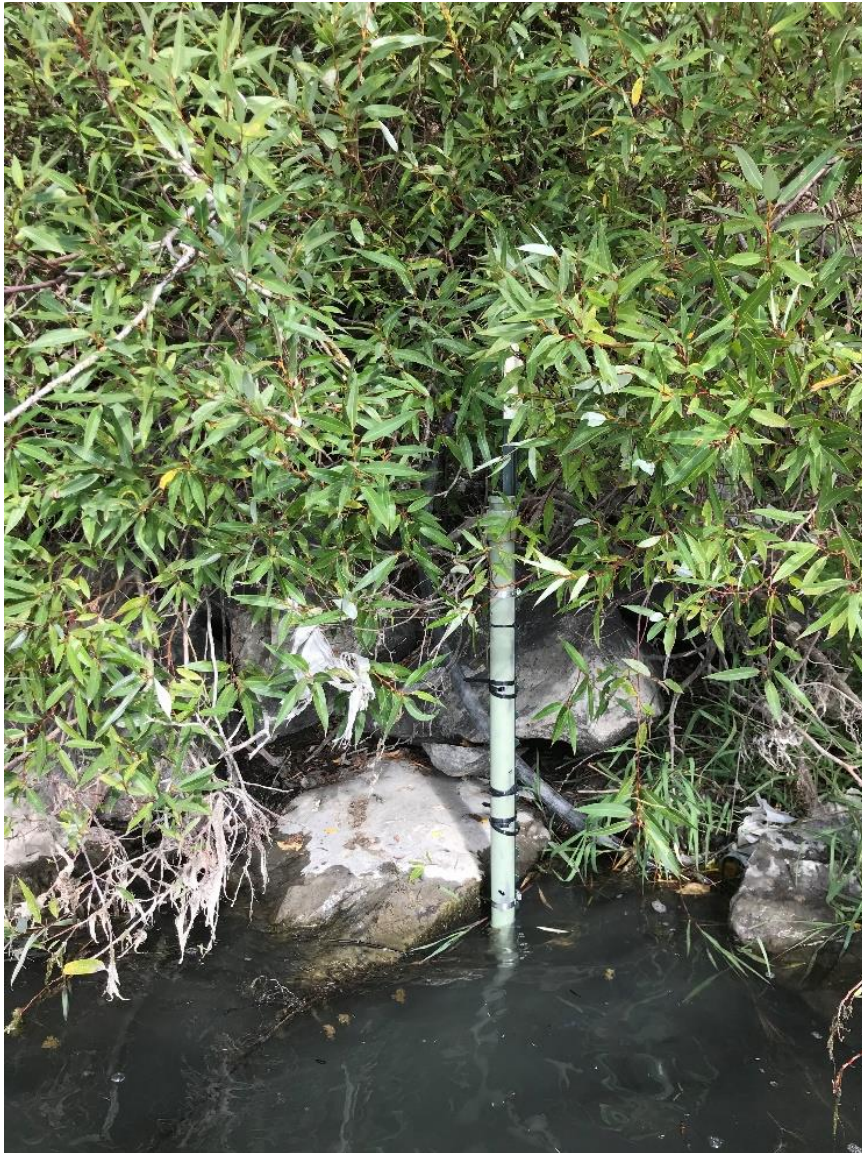
R-2 is located on the east bank of the river and is accessed from the Fortuna Riverwalk trail (Figure 8). The device is housed in a PVC housing secured to two tee posts with an additional tee post used as a horizontal reinforcement and is camouflaged with paint and hidden in vegetation to deter vandalism. The pressure transducer/data logger used for barometric

Figure 8. Gauge in housing at R-2

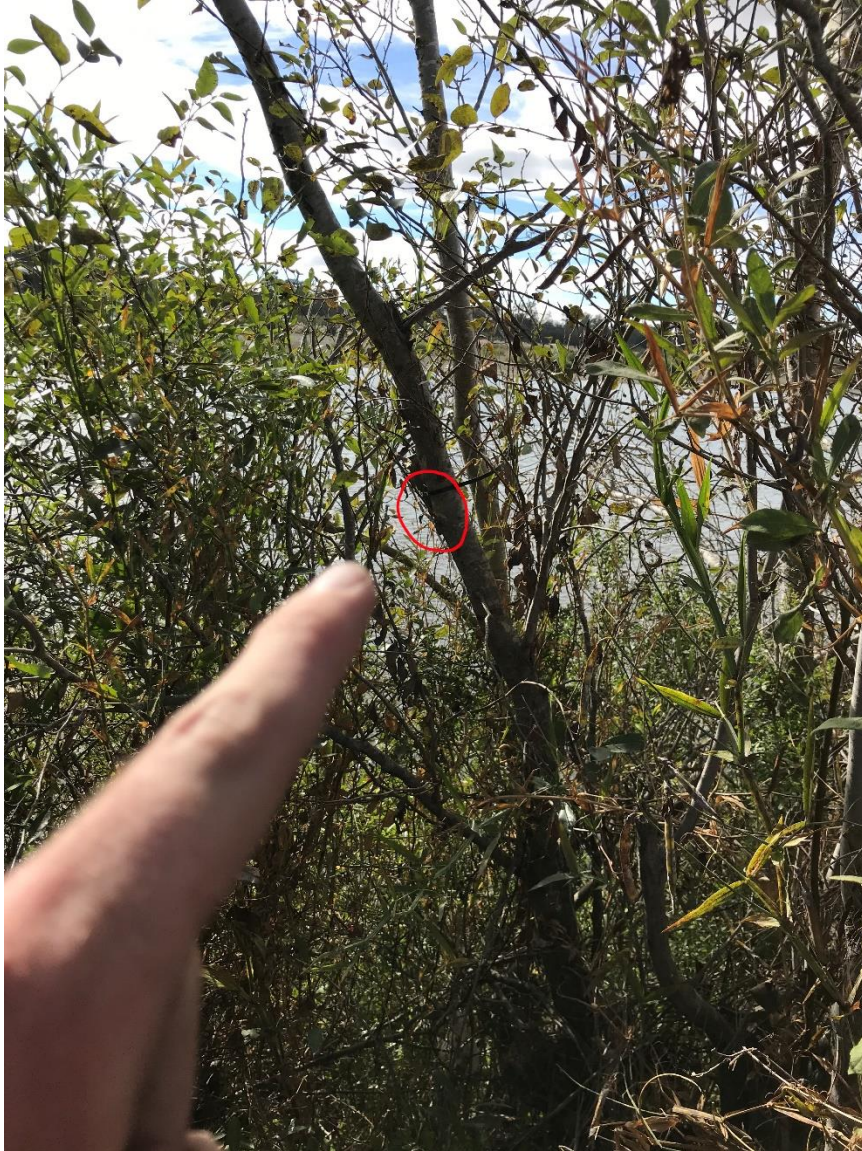
compensation is located in an alder tree near R-2, above the high-water mark. Three benchmarks were established in this location: the top of the tee-post holding the data logger housing, a blaze orange spot on a rip-rap boulder, and a blaze orange spot on a boulder upslope from the gauge.

Figure 9. Barometric pressure data logger installed in alder tree

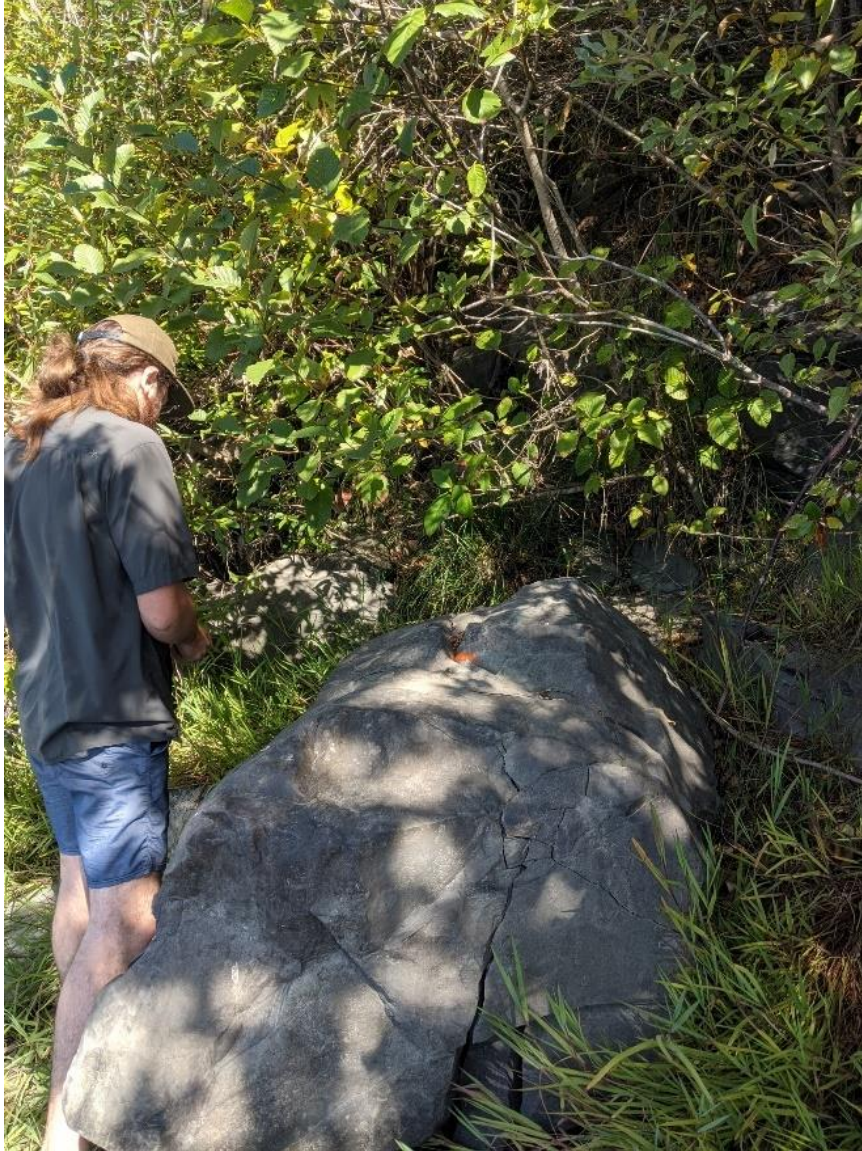
Figure 10. BM2 at R-2: blaze spot on boulder

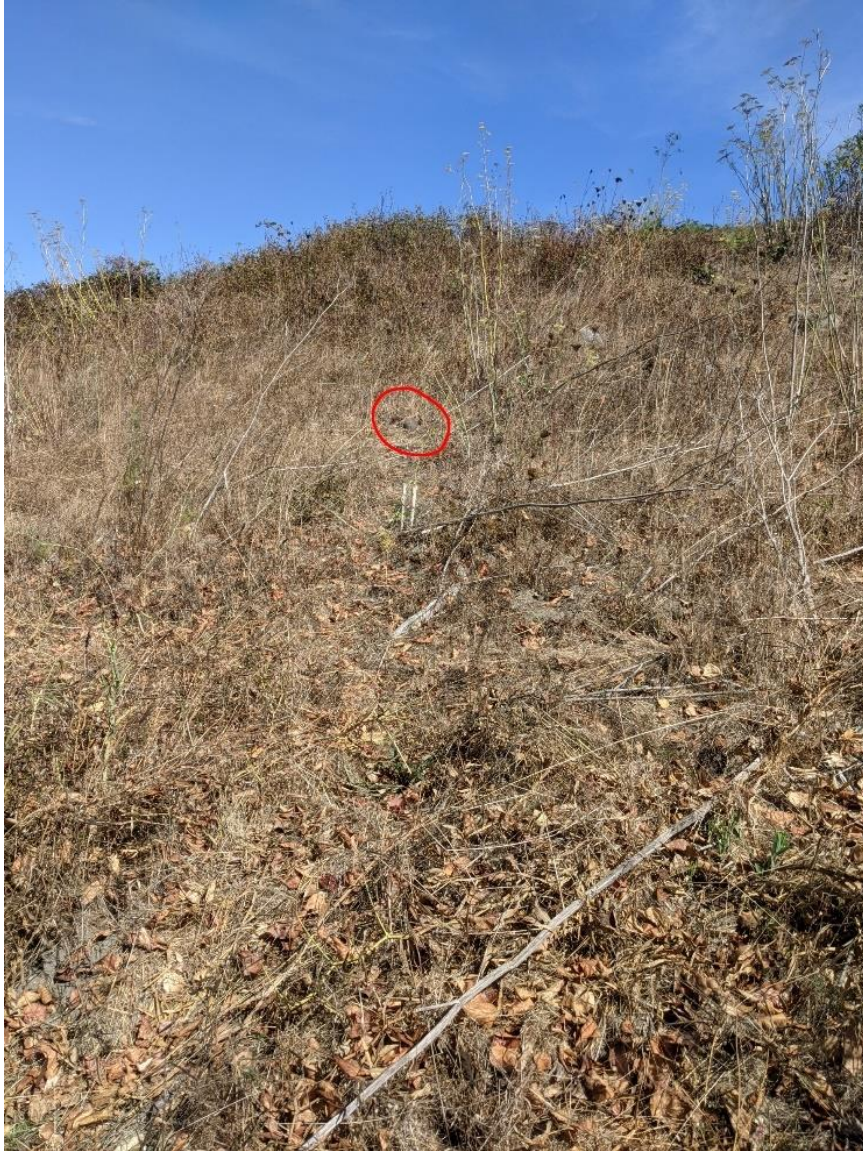
Figure 11. BM3 at R-2: blaze spot on boulder

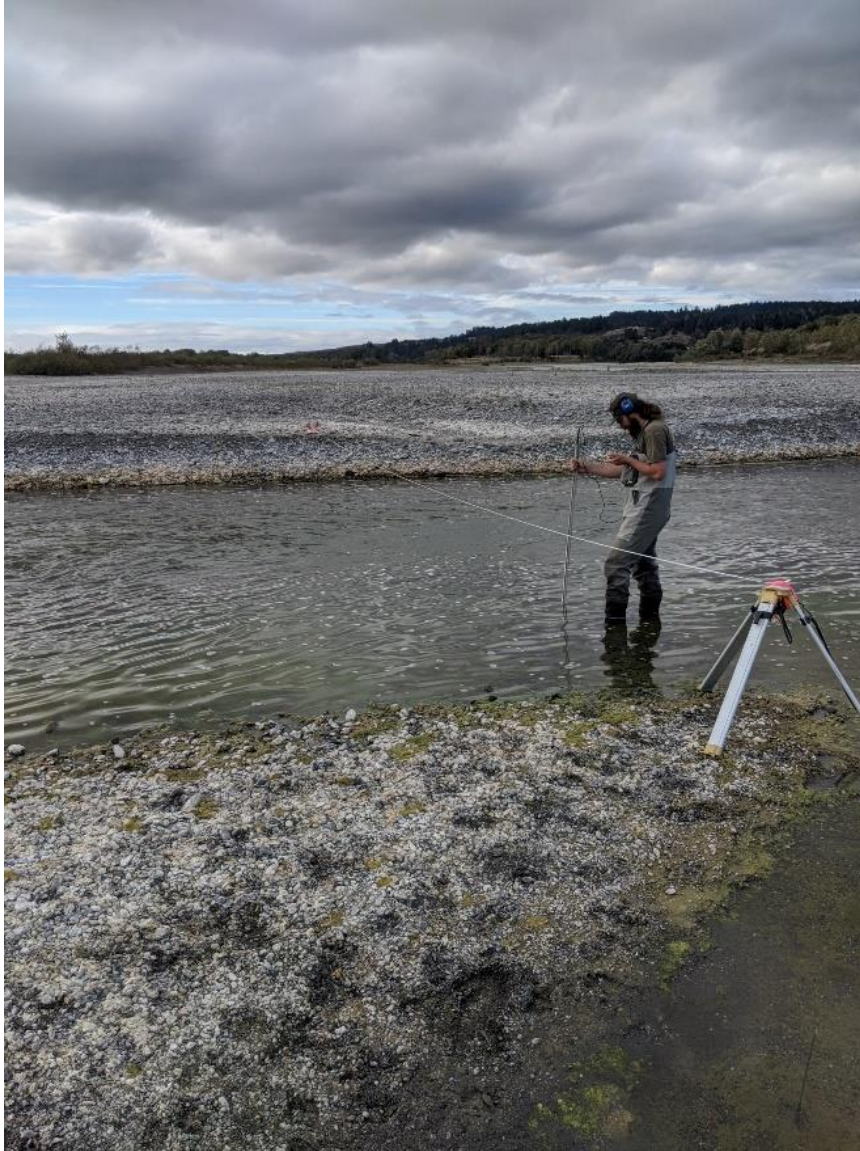
Figure 12. Streamflow measurement at QM-2

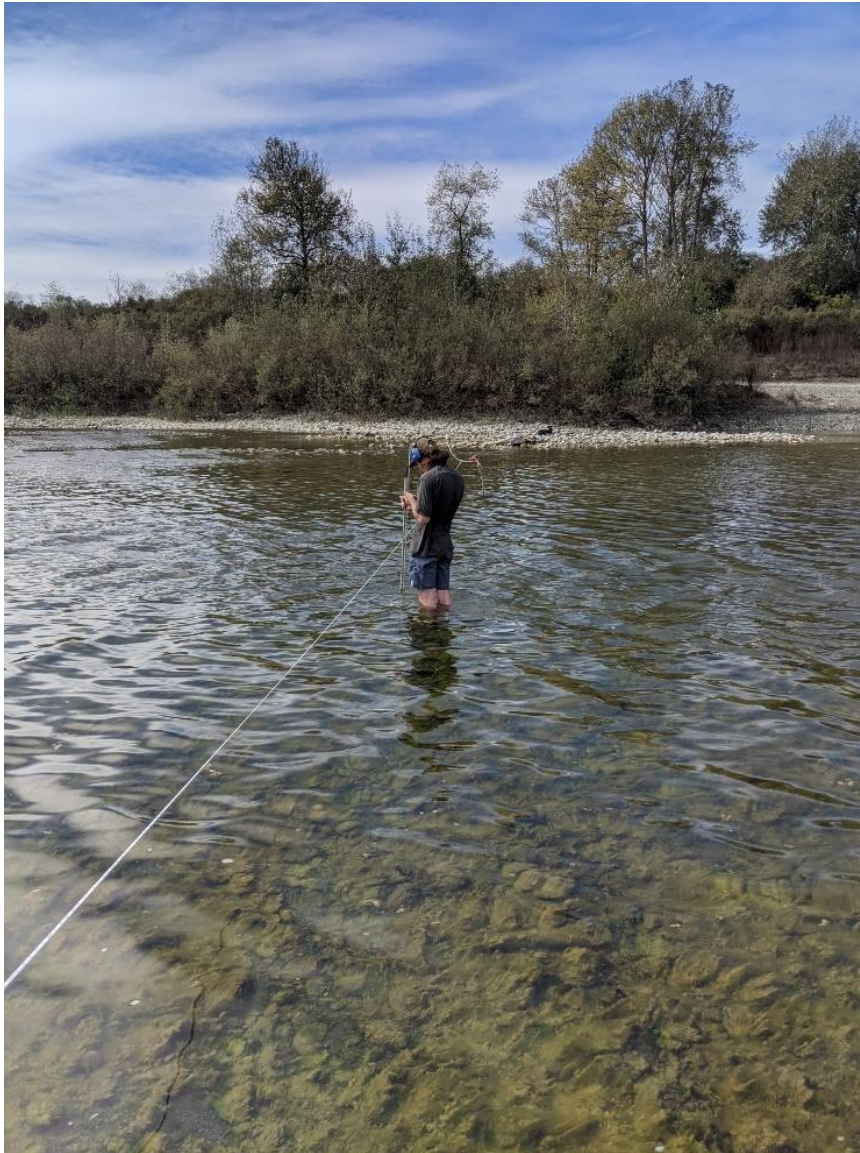
Figure 13. Streamflow measurement at QM-3

River stage was stable for the duration of all three flow measurements. The streamflow measurement at QM-3 was made at a split channel and discharge was calculated as the sum of the flow in the main channel and the flow in side channel.

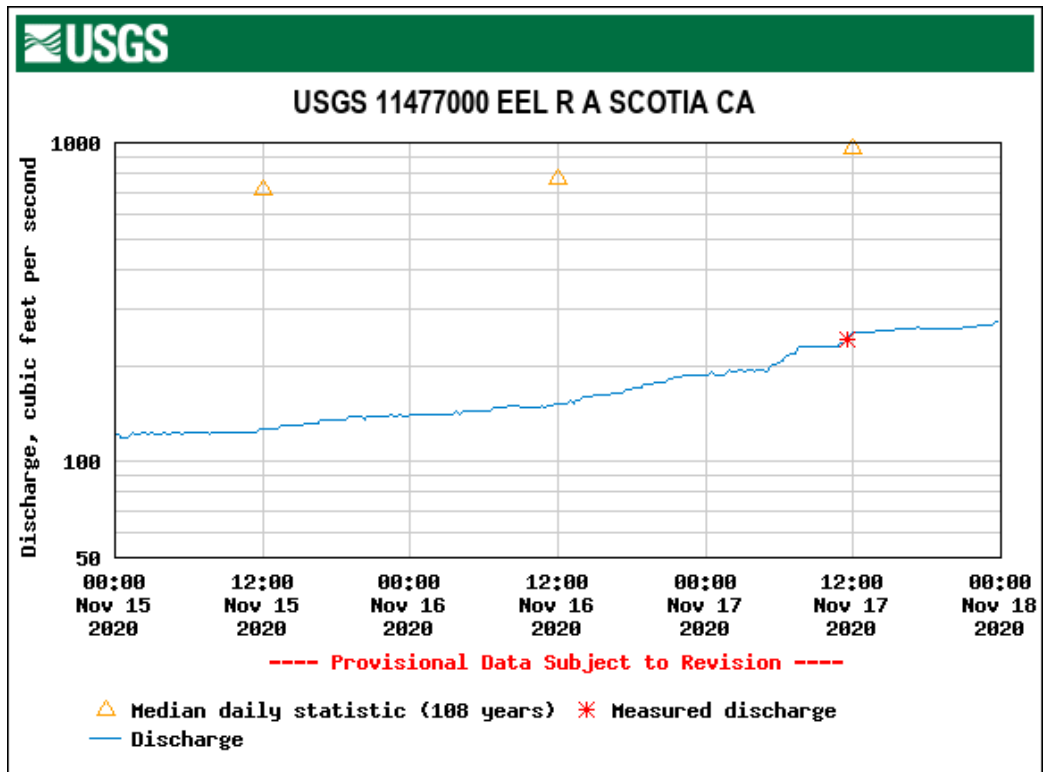
The nearest USGS stream gage (11477000) is located in Scotia, approximately 7.7 river miles upstream of R-3 (Figure 1). Measured discharge at R-2 and R-3 do not vary greatly from the reported values from the Scotia gauge (Table 1). Discharge at R-5 varied by a greater amount (9.1 cfs), but this may be explained by its greater distance from the USGS gauge.

Figure 1. USGS hydrograph for Eel River at Scotia; 15 Nov 2020 – 17 Nov 2020

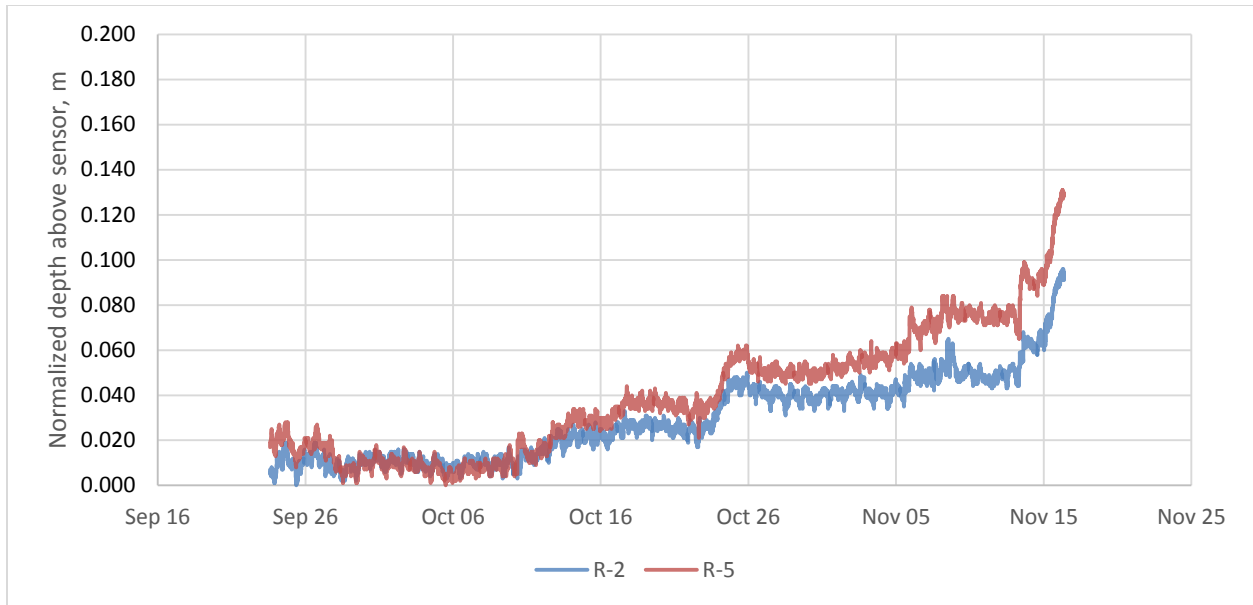
RTK surveyed water surface elevations were paired with stage data downloaded from the installed HOBO data loggers to calculate a time series of water surface elevations at each gauging site. To compare values between sites, elevations were normalized by subtracting the minimum value at each gauge from all values at that gauge so that the minimum value is set to zero (Figure 2).

The river stage shows some diurnal variation, which is more pronounced prior to 15 October. Small diurnal variations are seen throughout the record—generally ± 1 cm each day. Over the entire record, the difference between the smallest and largest stage values is 9.7 cm at R-2 and 13.1 cm at R-5.

Figure 2. Normalized stage data at R-2 and R-5 from 23 Sep 2020 - 16 Nov 2020

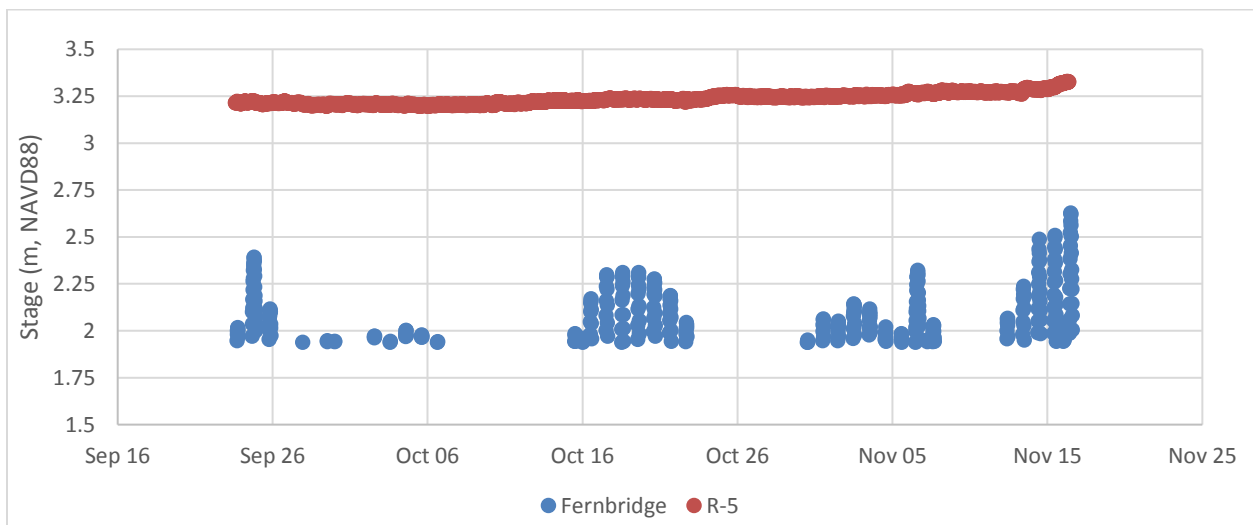
Values at R-5 were examined for potential tidal influence. Stage values from the USGS gauge at Fernbridge were converted to NAVD88 elevations and compared to water elevation values at R-5. During the king tides of 15-16 November 2020, river stage at Fernbridge remained approx. 0.75 meters below the elevations at R-5, suggesting that the gauging site is free of tidal influence.

Figure 3. Stage data from Fernbridge (USGS 11479560) converted to NAVD88 elevations

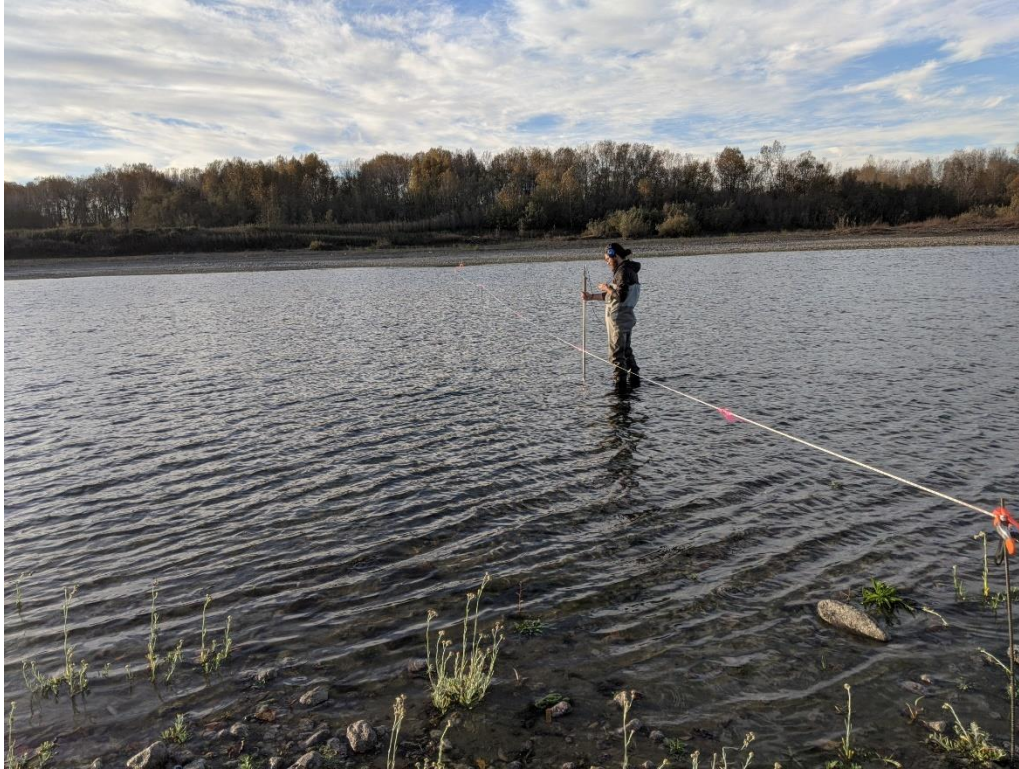
Figure 4. Discharge measurement below R-5

Discharge measurements were made below each gauging location on 16 November 2020 (Table 1; Figures 3, 4, 6). Velocities were measured using a Price AA-type current meter and the USGS standard rating equation. River stage at each location was stable for the duration of the measurement, but the stage in Eel River rose slowly throughout the day.

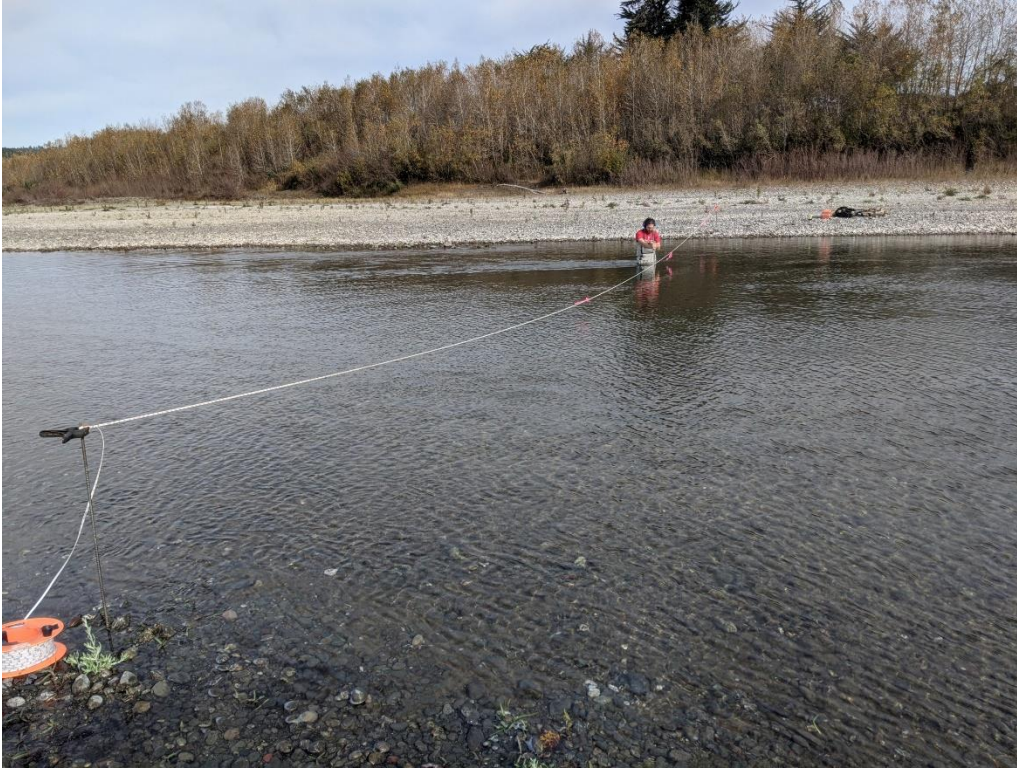
Figure 5. Discharge measurement below R-2

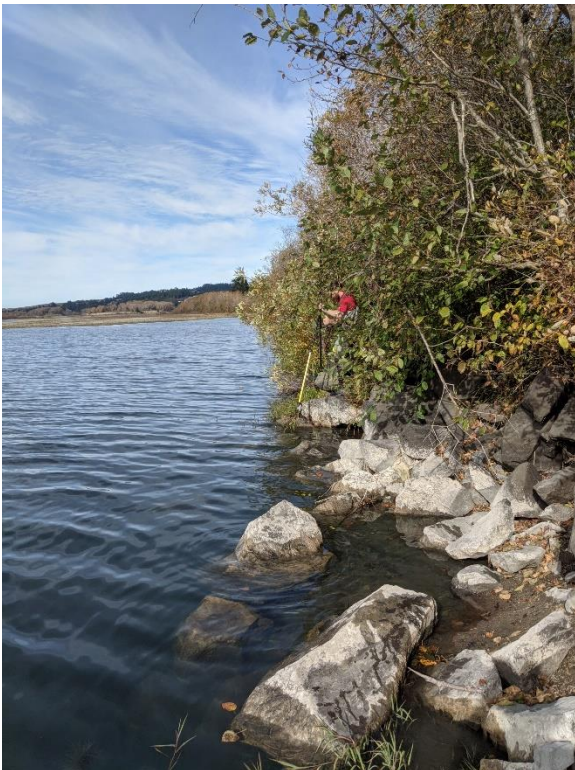
Figure 6. RTK survey of water surface elevation at R-2

TGAEC completed a survey of benchmarks and water surface elevations at each of the gauging sites (Table 3). Each point was measured using a Hemisphere S321 RTK GNSS antenna connected to the California Real Time Network (CRTN), utilizing station P160 at Hydesville. Data for each position was collected using the average value of 300 points recorded over a 5-minute period.

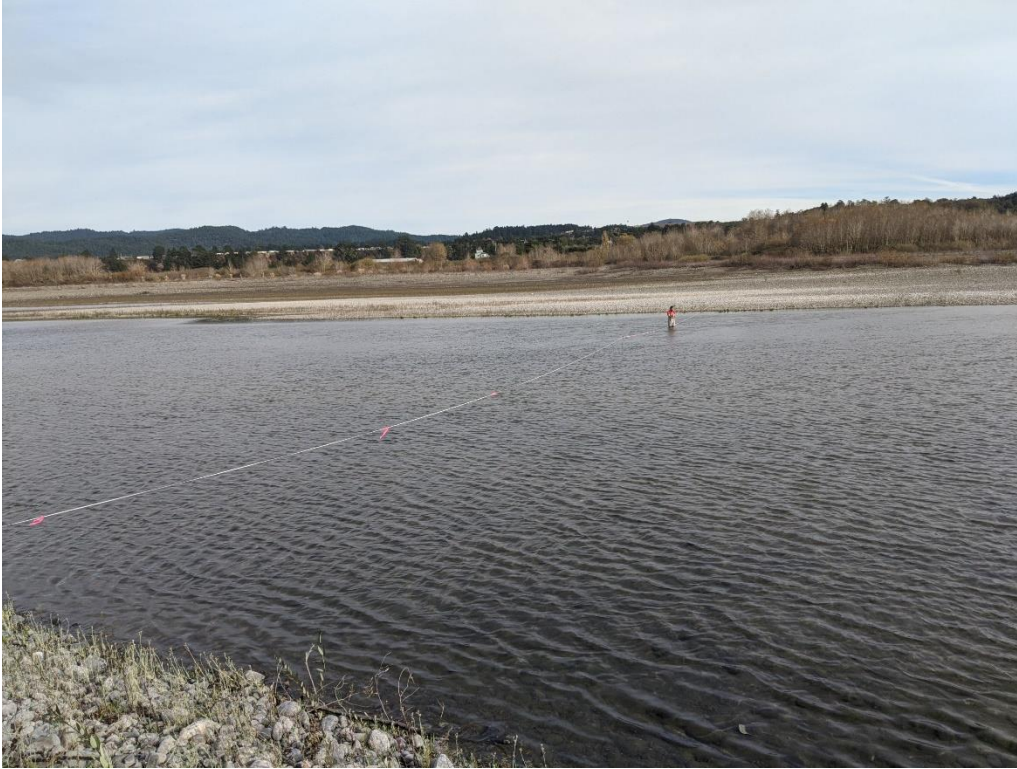
Figure 7. Discharge measurement below R-3

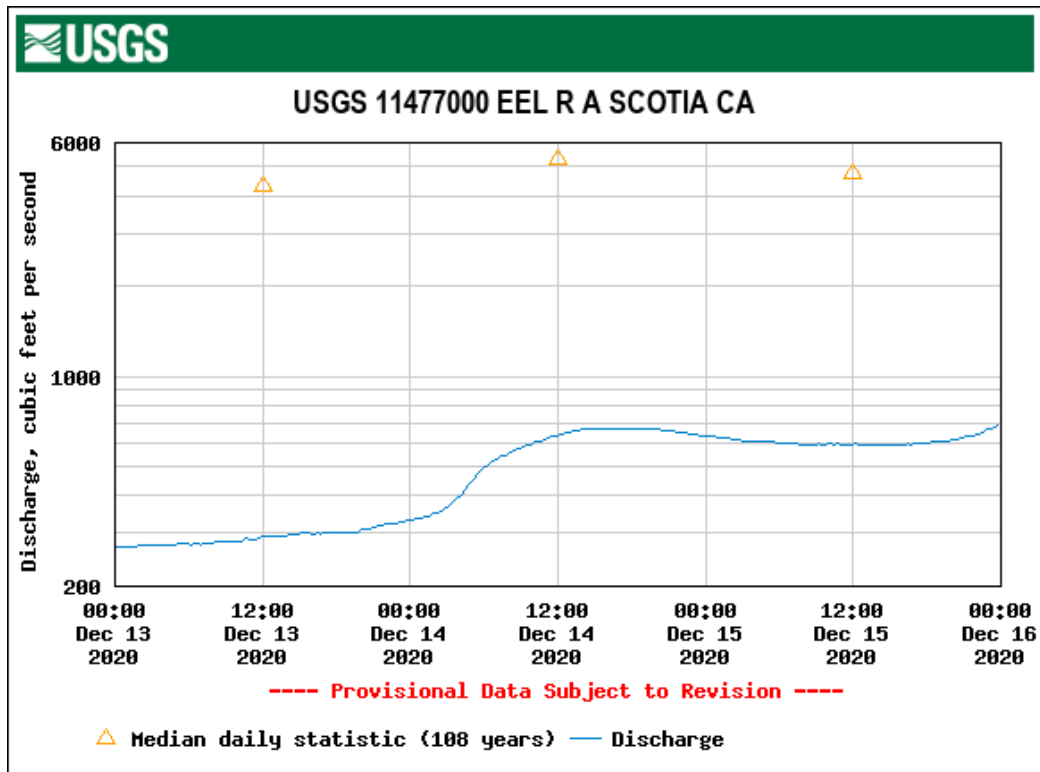
The nearest USGS stream gage (11477000) is located in Scotia, approximately 7.7 river miles upstream of R-3 (Figure 1). Measured discharge at all 3 locations are greater than the sum of the reported discharge from USGS. The USGS stream gage on the Van Duzen River (11478500) is located upstream from Yager Creek, which may explain some of the difference in the measured and reported discharges (Figure 2).

Figure 1. USGS hydrograph for Eel River at Scotia; 13 Dec 2020 – 16 Dec 2020

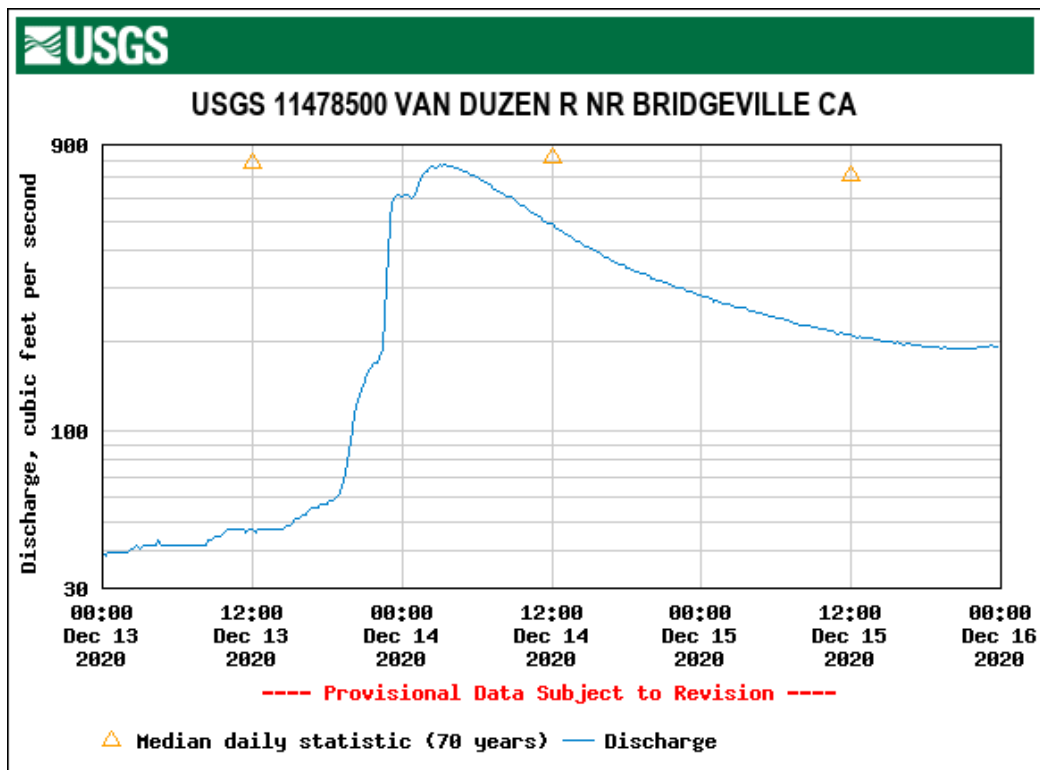
Figure 2. USGS hydrograph for Van Duzen River near Bridgeville; 13 Dec 2020 – 16 Dec 2020
