Jacoby Creek Water Sustainability and Anadromous Fish Habitat Enhancement Feasibility Study

Appendix C-1.
 Mapped flow paths across floodplain during frequent and larger flood events. Downstream of Old Arcata Road.

Appendix C-2.
Mapped flow paths across floodplain during frequent and larger flood events. Upstream of Old Arcata Road.

Historical Floodplain Inundation Images (1948 – 2022)

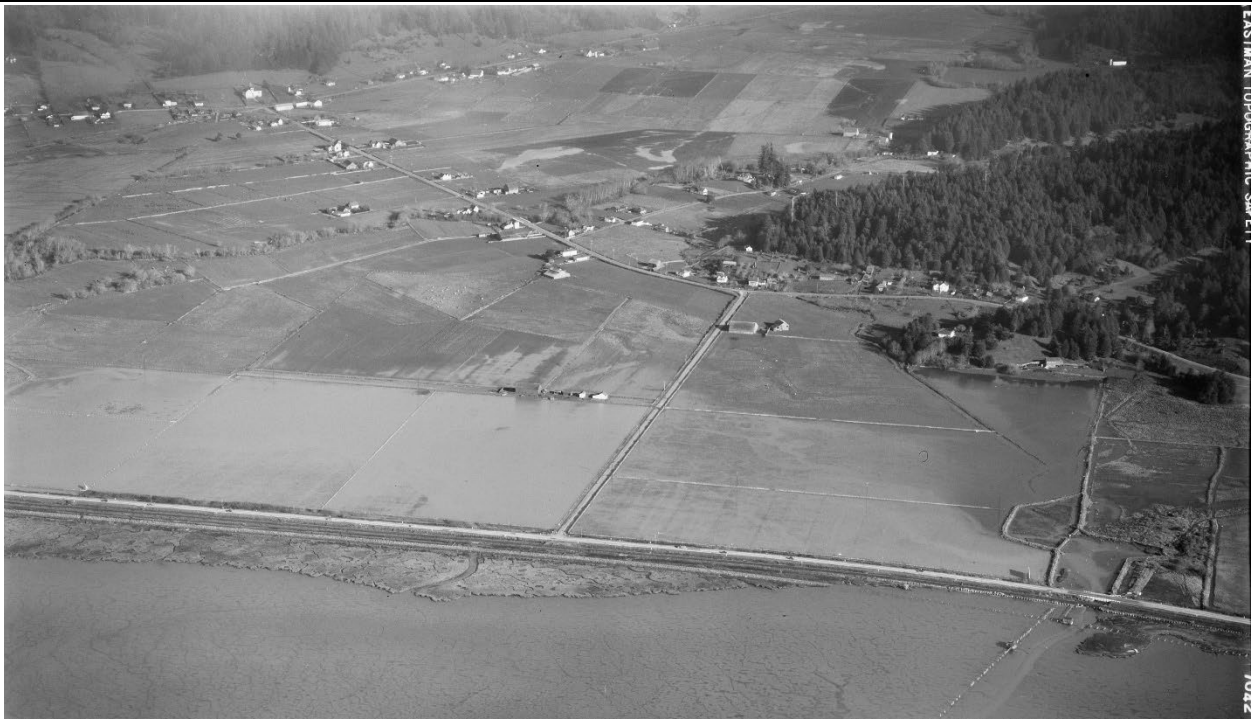
Figure 1. January 8, 1948. From Cal Polly Shuster Collection.

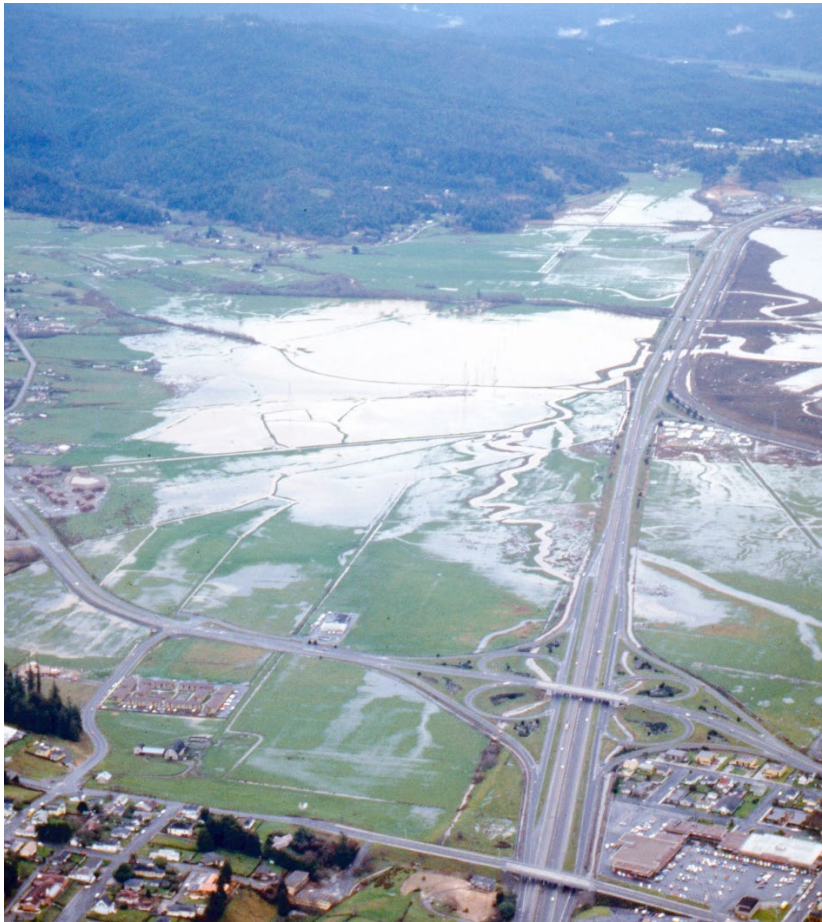
Figure 2. January 16, 1974 – Arcata Baylands, US 101 a and Samoa Blvd/OAR (Humboldt County Dept. of Public Works).

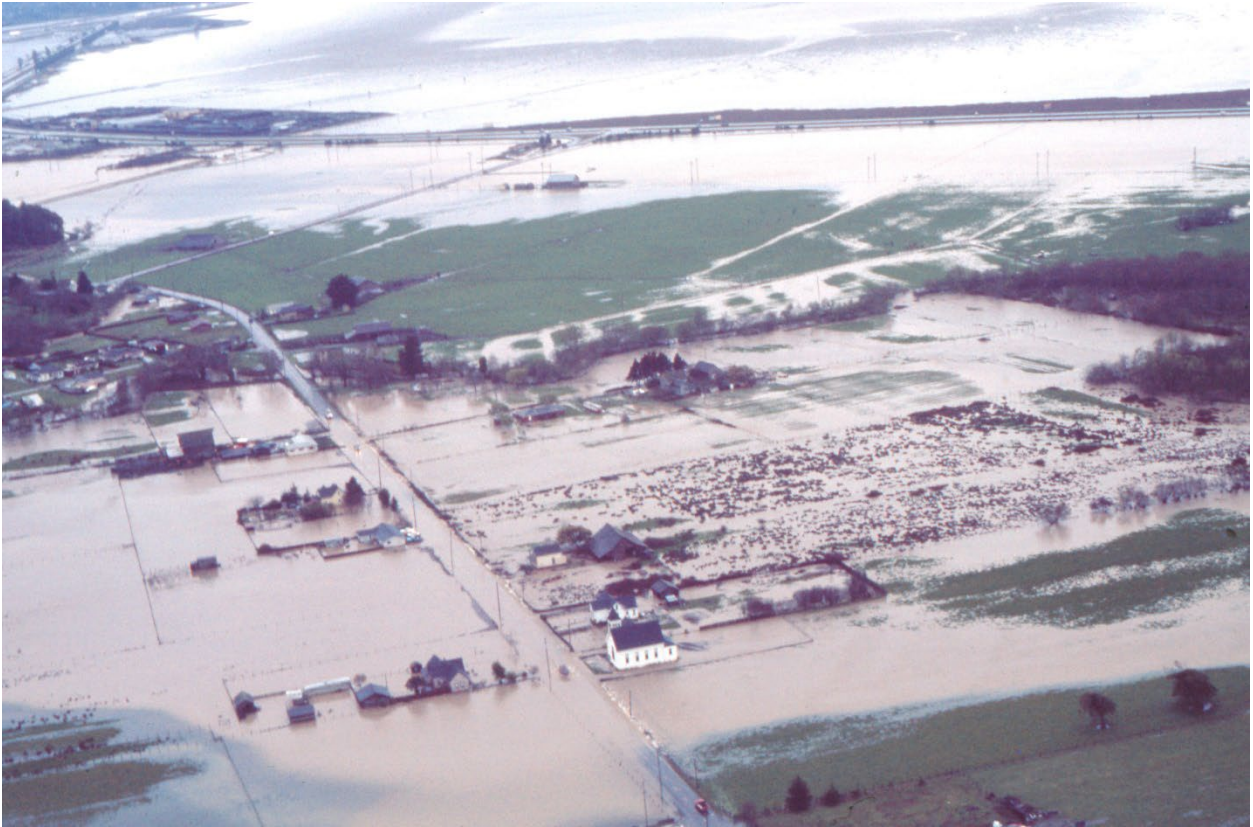
Figure 3. March 18, 1975 – OAR crossing Jacoby Creek valley (Humboldt County Dept. of Public Works).

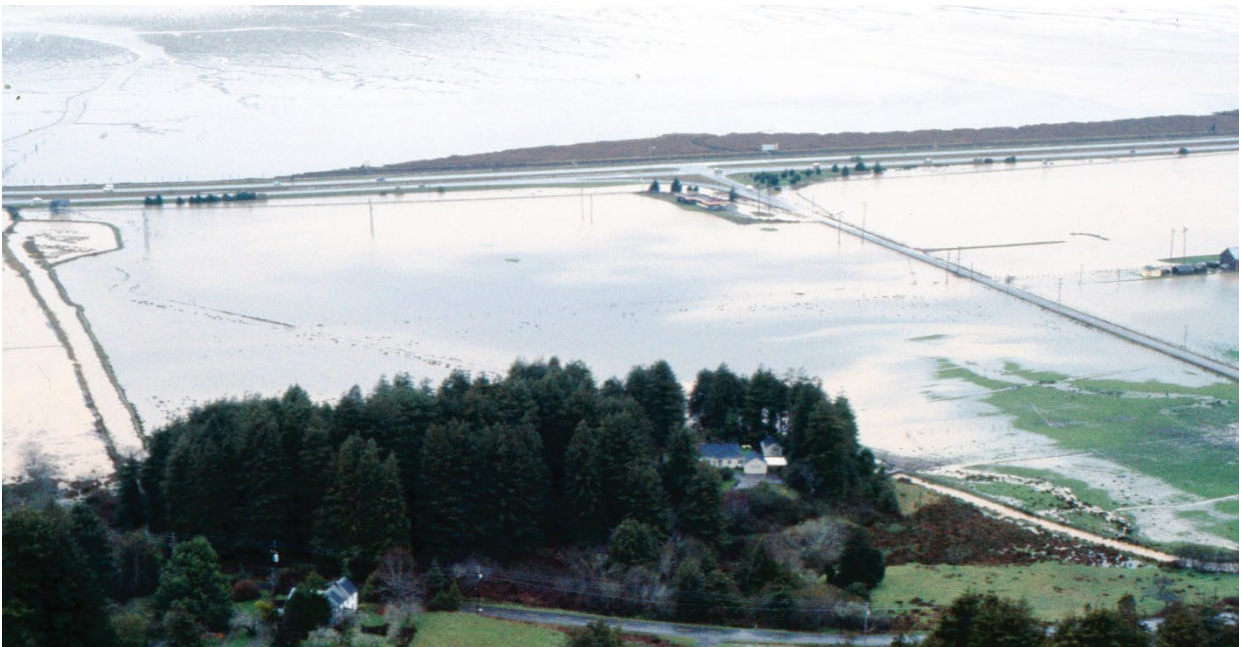
Figure 4. March 18, 1975 – Washington Gulch, Bayside Cutoff, and US 101 (Humboldt County Dept. of Public Works).

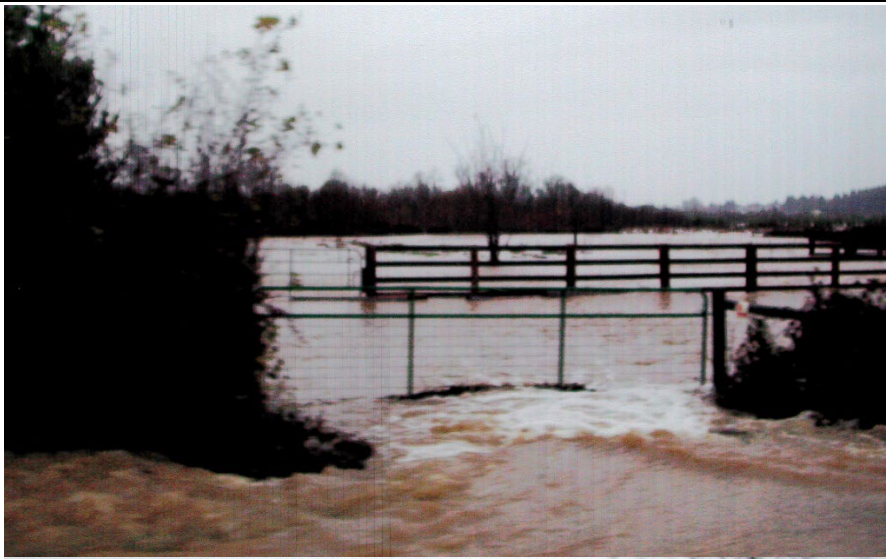
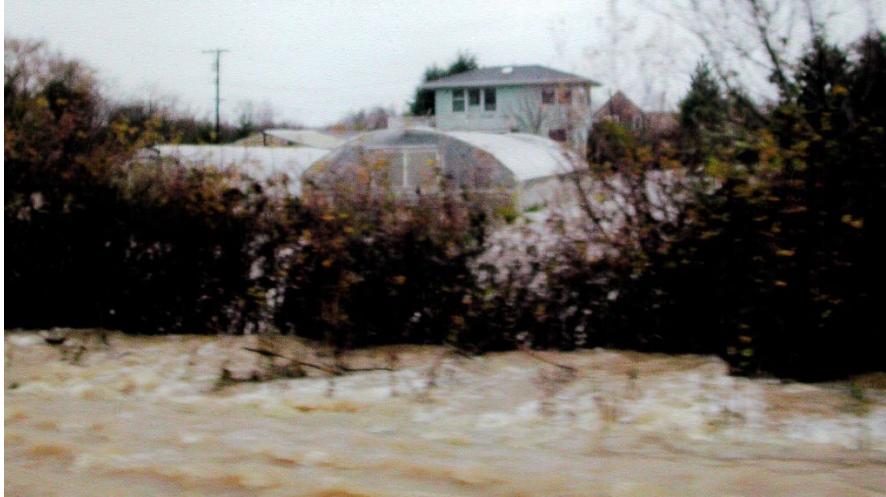
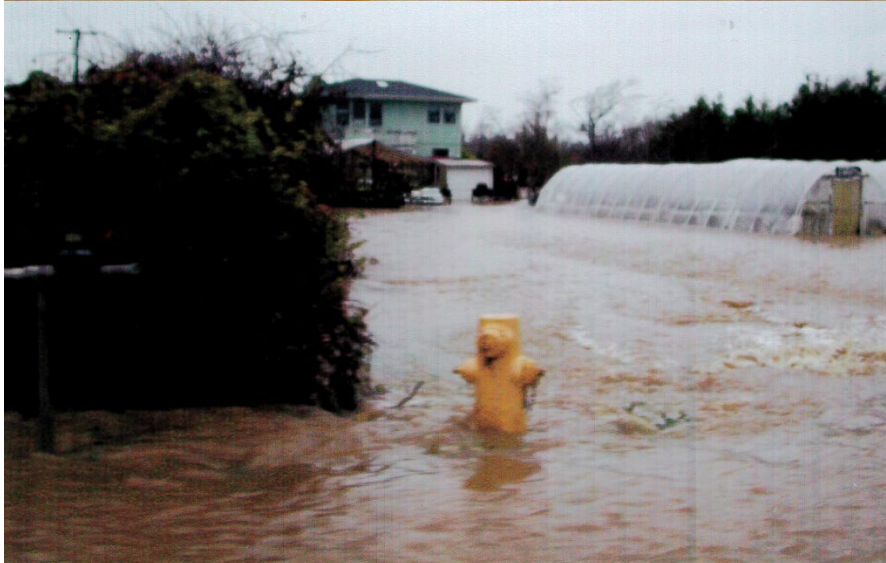
1/1/2003
Figure 5. January 1, 2003 – Photos of flooding across Old Arcata Road and onto properties to the west, taken from Kokte Ranch driveway (Jacoby Creek Land Trust).

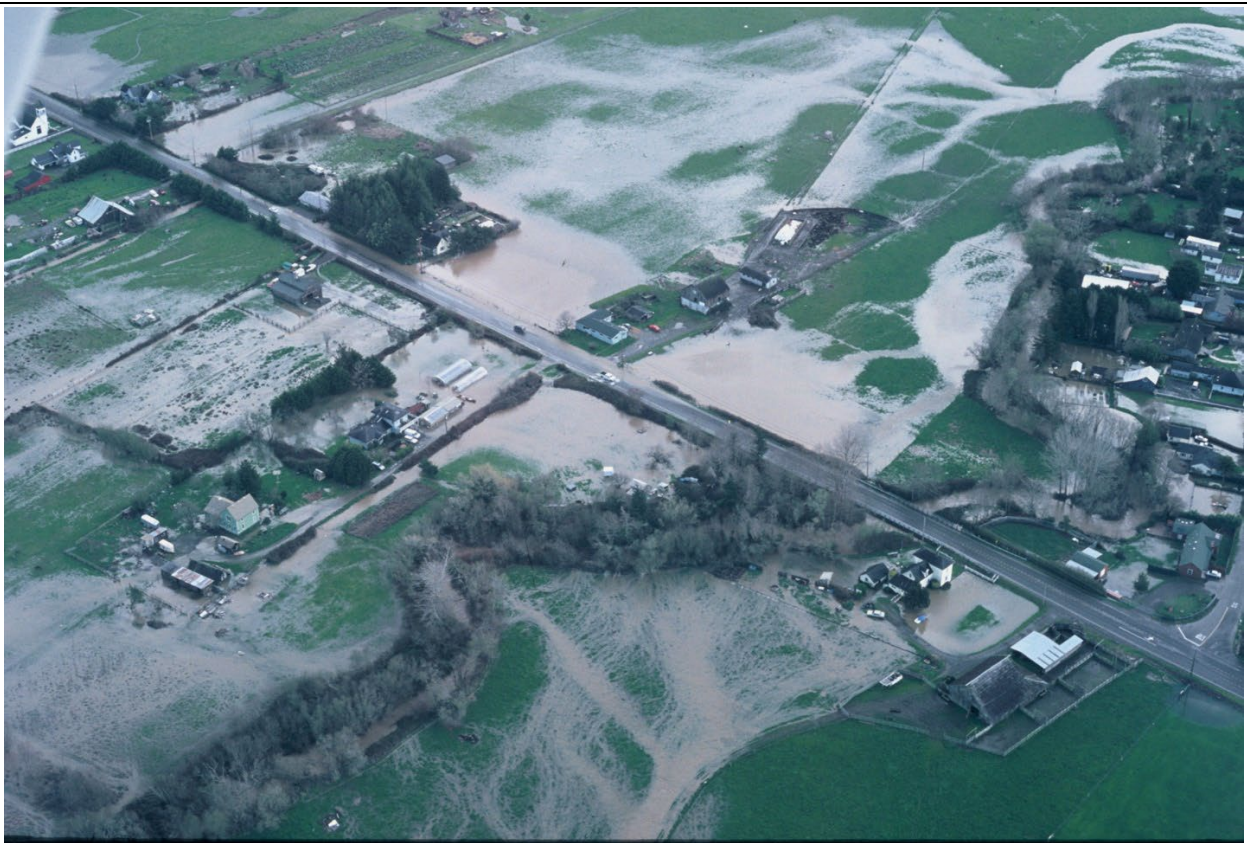
Figure 6. February 18, 2004 – Old Arcata Road at Jacoby Creek Bridge, facing east. (Humboldt County Dept. of Public Works).

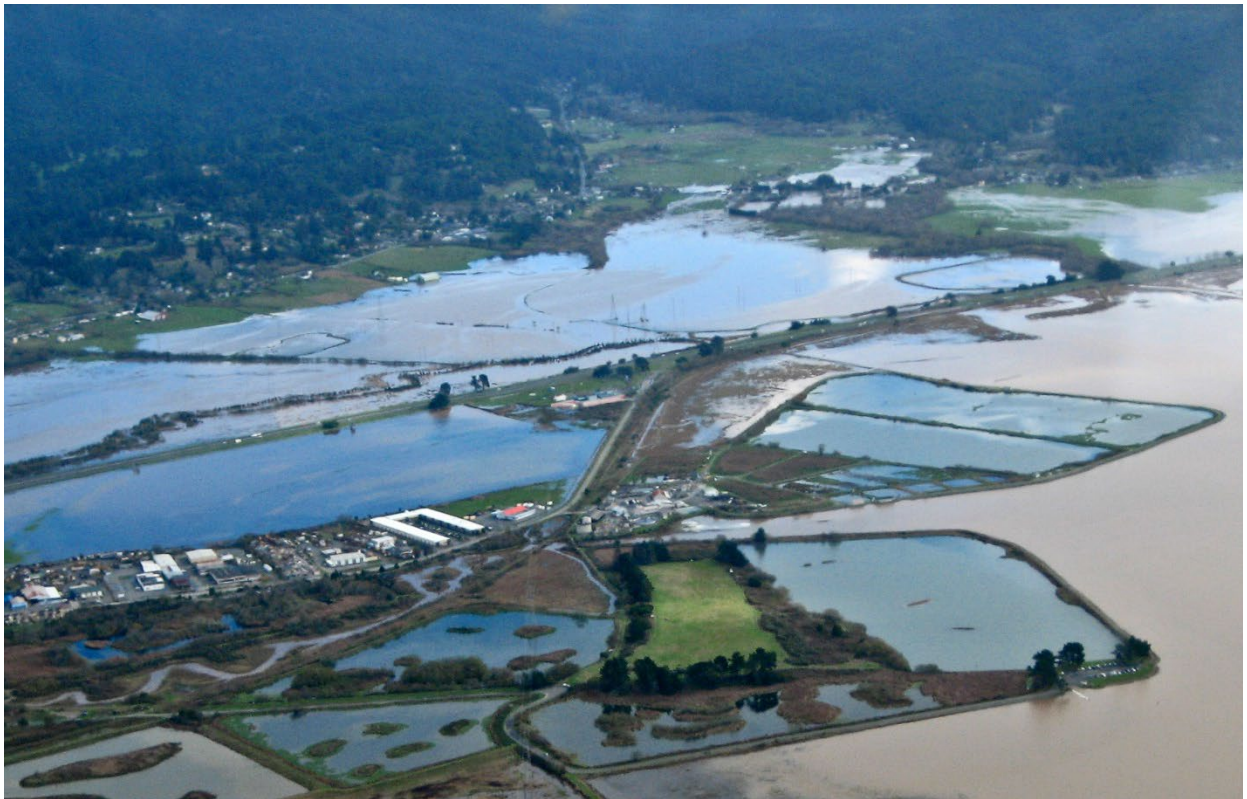
Figure 7. December 2, 2012 – Looking east from Arcata marsh towards inundated Arcata Baylands (Brad Finney).

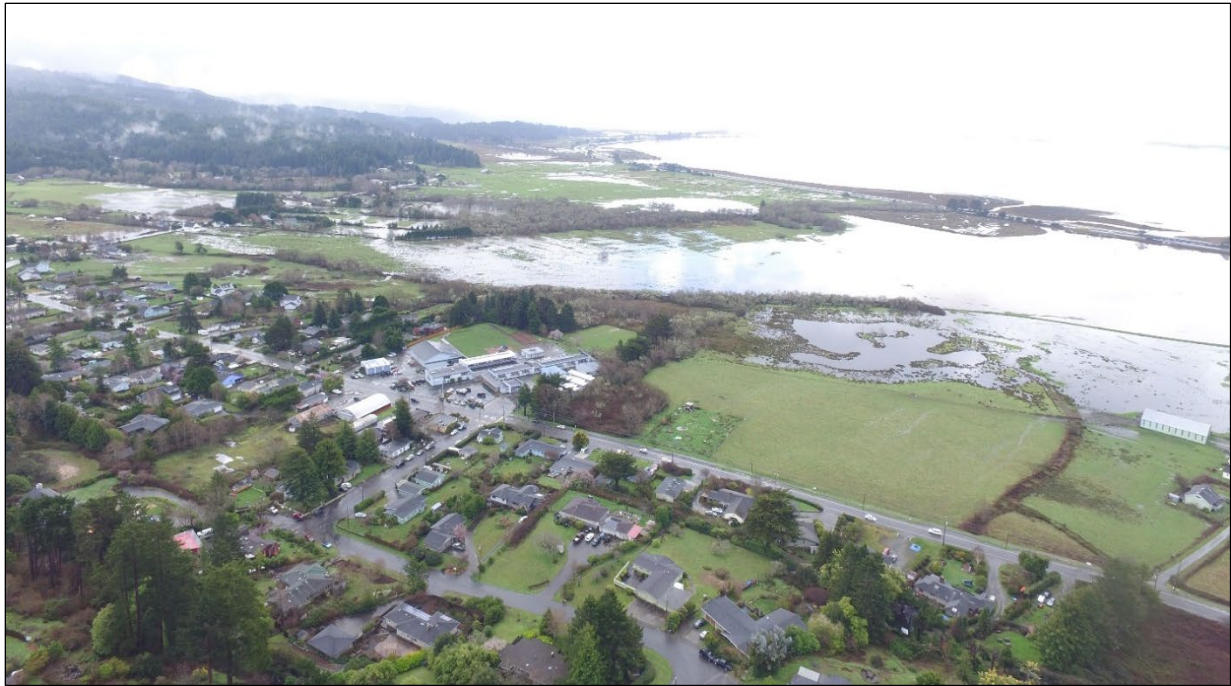
(a)

Figure 8. February 16, 2019 – Looking south across Old Arcata Road towards Arcata Baylands and (b) southeast towards Old Arcata Road and the JCLT.

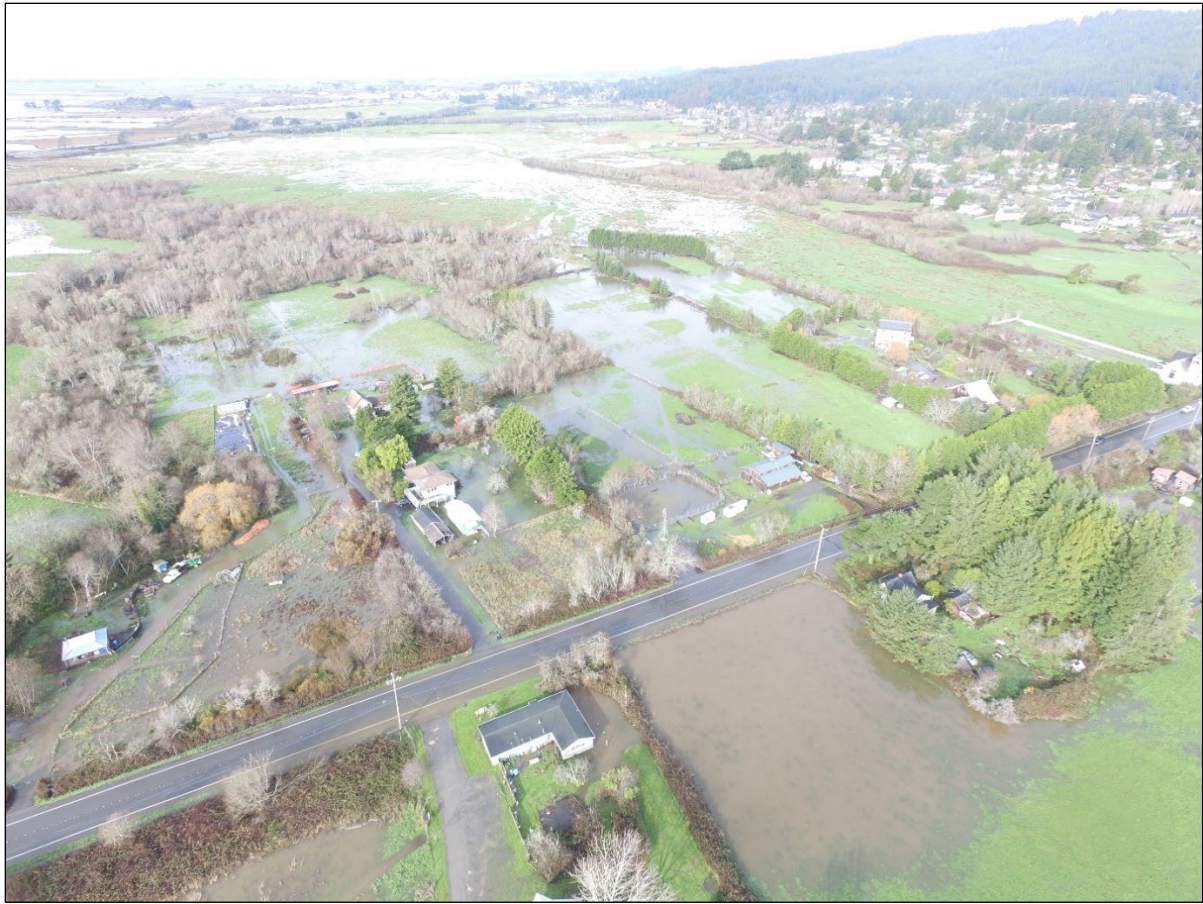
Figure 9. December 27, 2021 – Looking (a) northwest and (b) southwest across Old Arcata Road

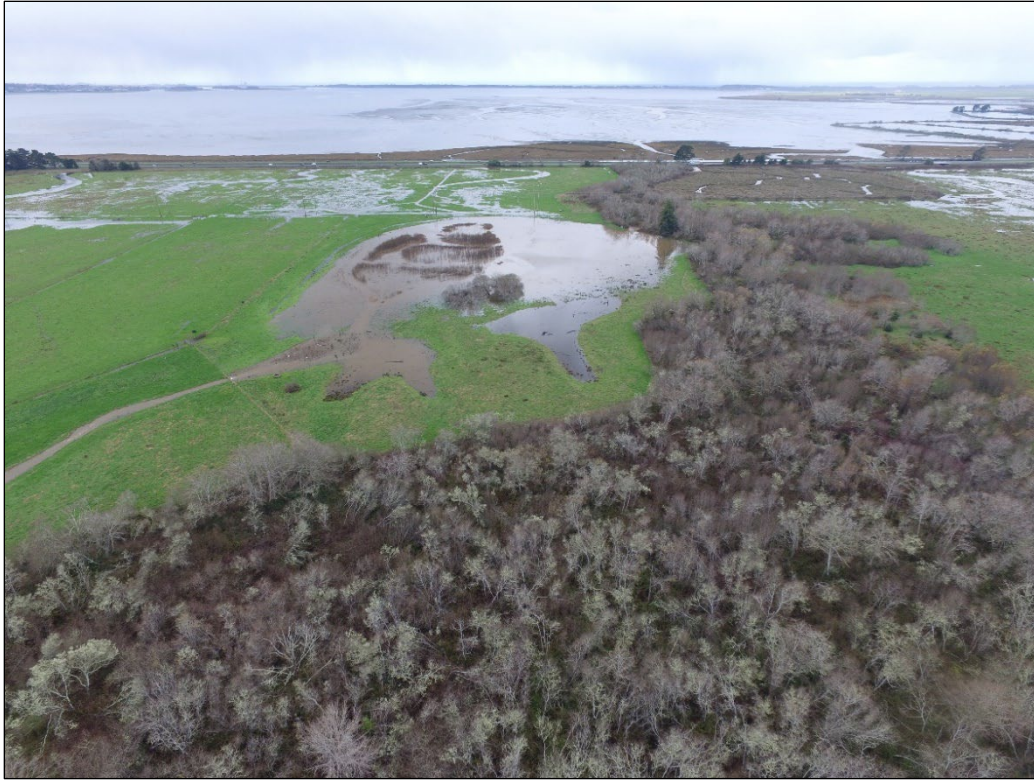
Figure 10. December 27, 2021 –Looking (a) west to the South Jacoby Wetland Complex and US 101 and (b) east towards Old Arcata Road.

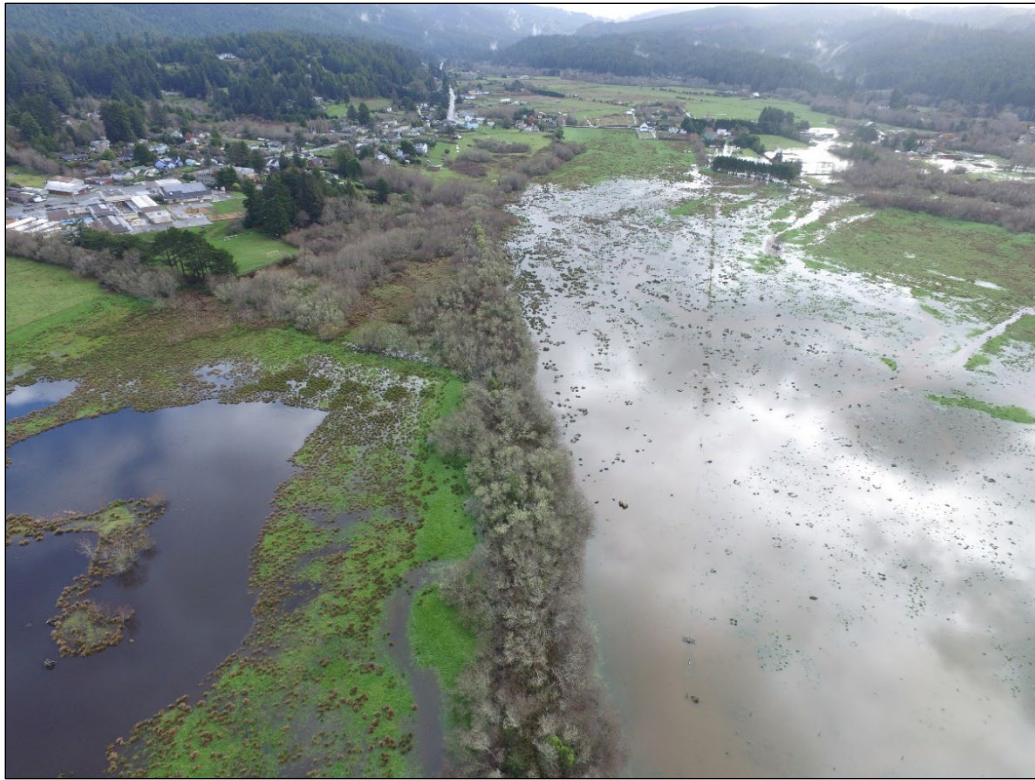
Figure 11. December 27, 2021 –Looking (a) east along the old railroad alignment towards Old Arcata Road and (b) west to Arcata Baylands North and US 101.
