Field Memo

Location: Lower Jacoby Creek, Bayside & Arcata, CA

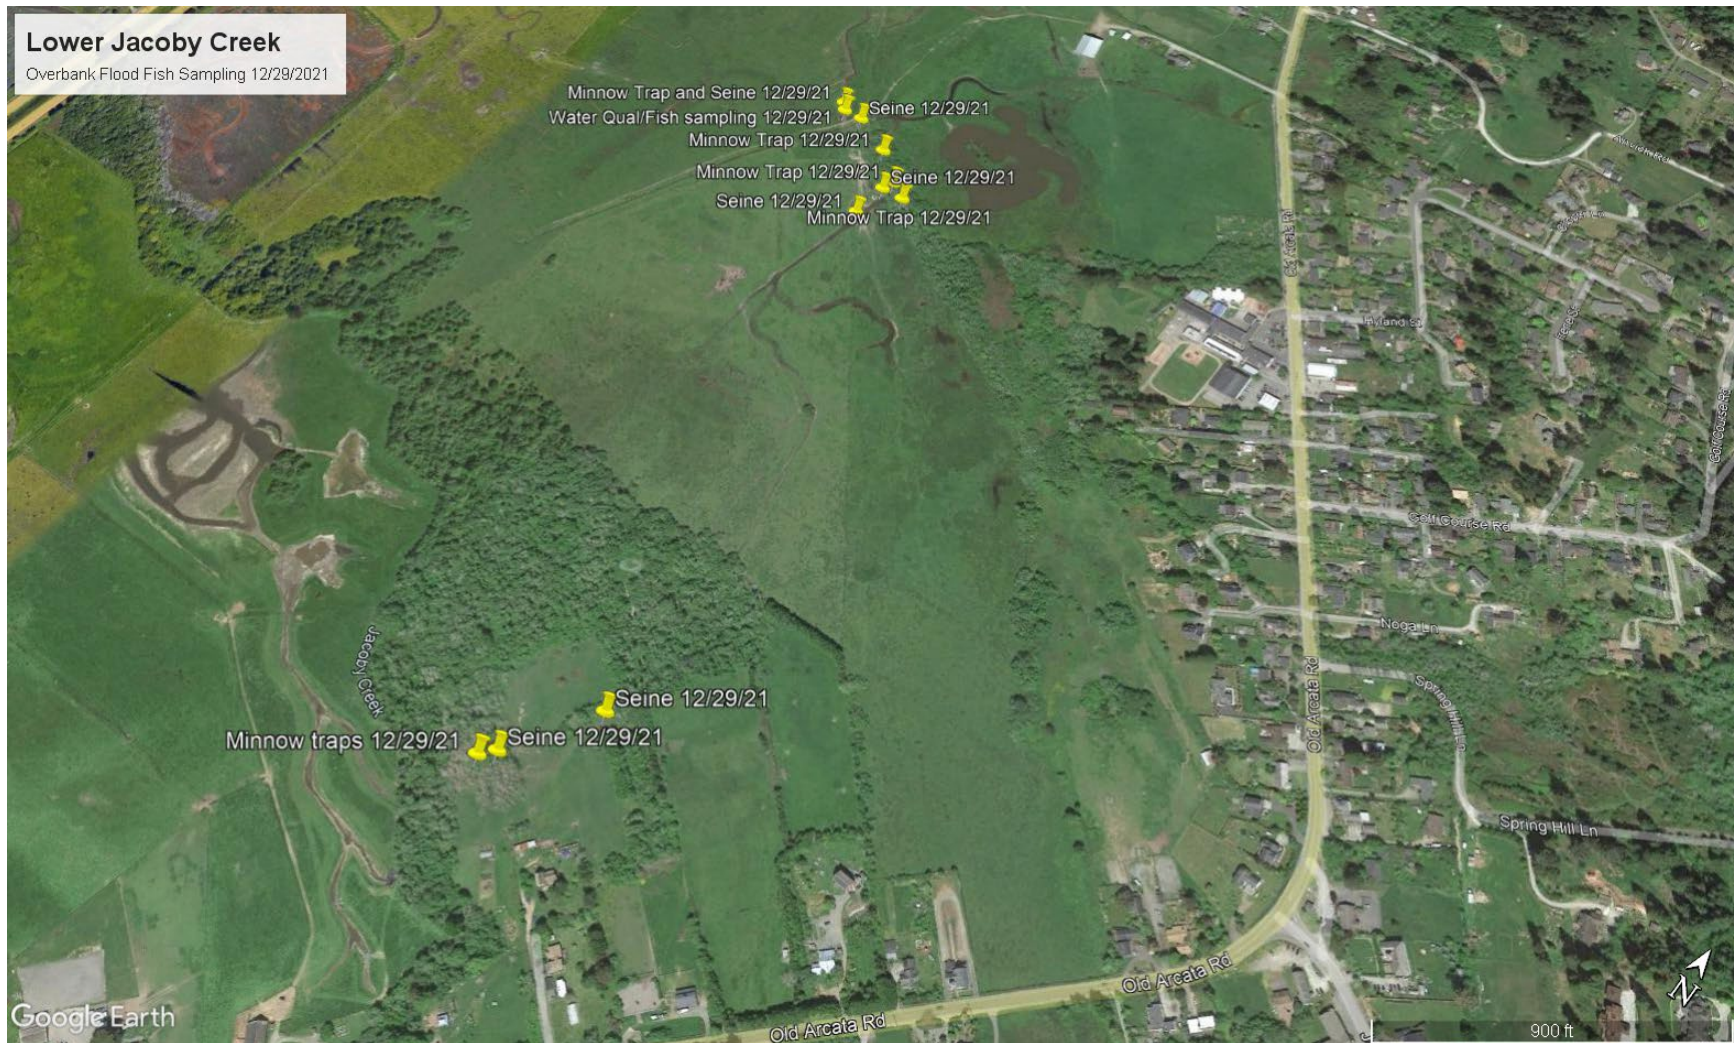
Figure 1. Lower Jacoby Creek locations for fish sampling following overbank flooding, 29-December-2021, Bayside and Arcata, California.

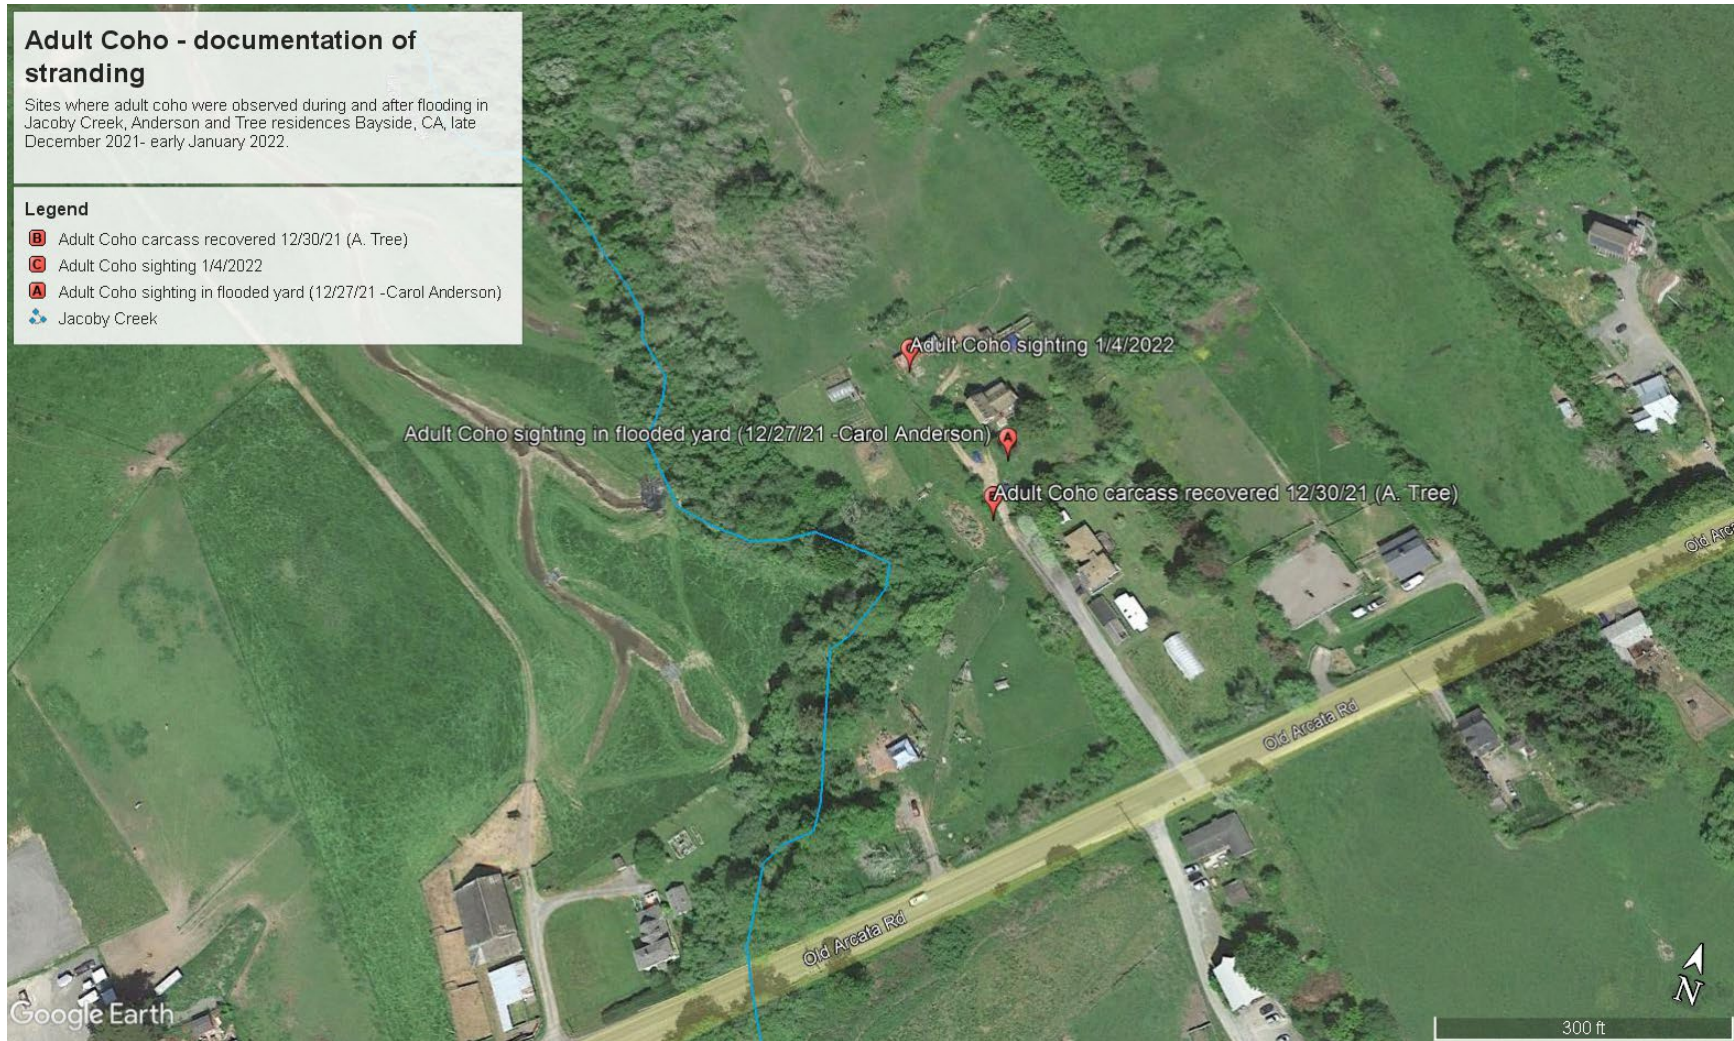
Figure 2. Locations where adult coho were observed stranded following over-bank flooding in Jacoby Creek, late December 2021- early January 2022, Bayside, CA

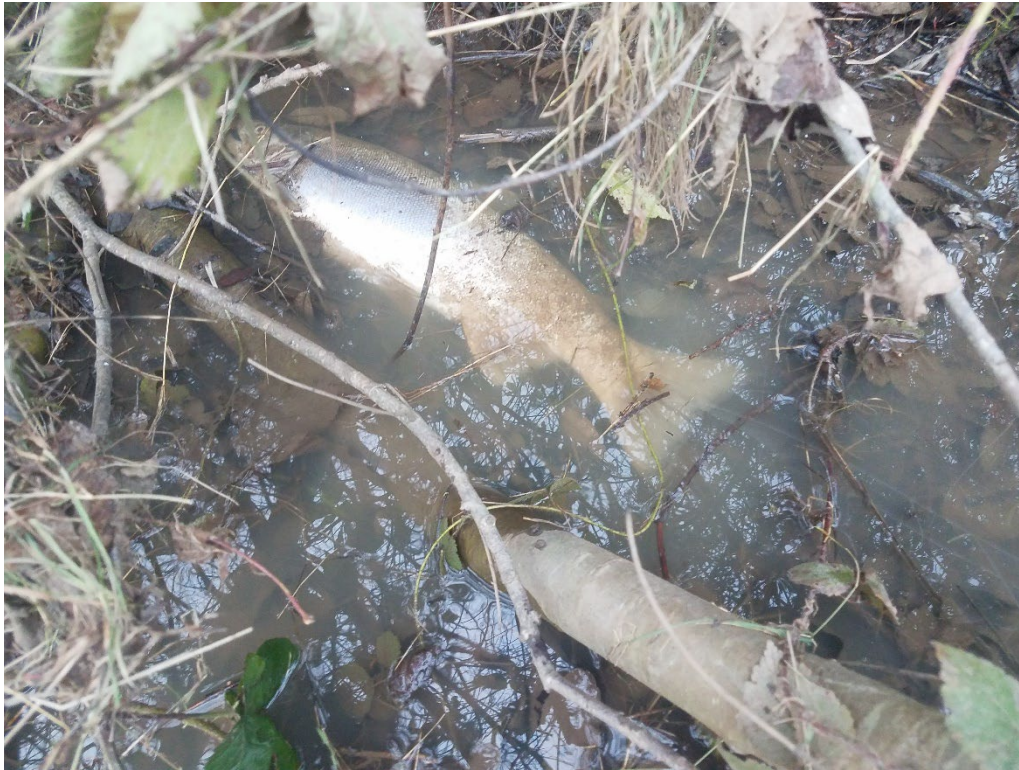
Plate 11. Carcass of adult Coho recovered after flooding 30-December-2021, Ash Tree's residence, Bayside, CA.
